Norderstedt, 28.08.2017/TKR

# FIELD SAFETY NOTICE (FSN)

#### Fluorocell PLT

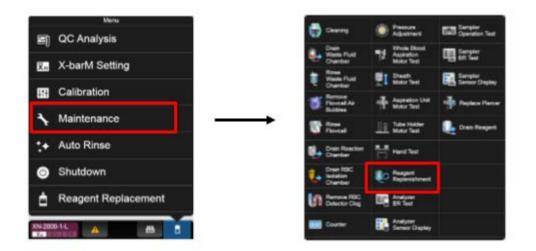
- Kindly discard the Fluorocell PLT of the affected lots that you might have on stock as per your local guidelines.
- Stop using the affected lots of Fluorocell PLT that you might currently have connected to your XN-Series analyser.
- Upon receipt of replacement lots, please ensure that the reagent replenishment for Fluorocell PLT is performed twice after executing reagent replacement. This is to ensure that the reagent in the analysers' tubing and chambers is completely exchanged by the new reagent lot. The 'Reagent Replenishment' option can be found in the analyser maintenance submenu (see image below).

• After reagent replenishment, analyse at least five human blood samples and verify the PLT-F scattergram for abnormalities (review above Fig. 1 and Fig. 2) to ensure the reagent is correctly replenished.

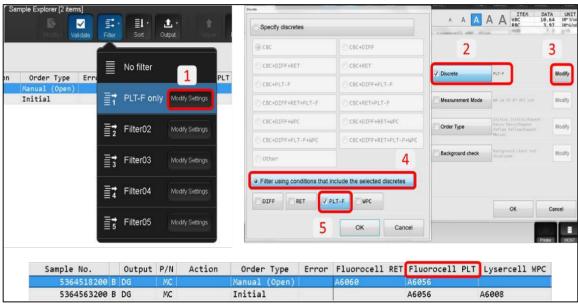
Fig. 3: Filtering of samples with PLT-F measurements. The Fluorocell PLT lot can be seen in the 'Reagent' tab for each measurement

Samples can be easily filtered in the sample explorer to focus on measurements with PLT-F, and samples with 'affected reagent lots' can be identified by using the 'Reagent' tab (see Fig. 3).
