**Update to Medical Device Correction  
Philips M1783A/M5526A Sync Cables & 989803195641 ECG Out Cables  
Electrical Interference Could Pose a Risk to Patients**

**URGENT - Medical Device Correction**  
**Philips M1783A/M5526A Sync Cables & 989803195641 ECG Out Cables**  
**Electrical Interference Could Pose a Risk to Patients**

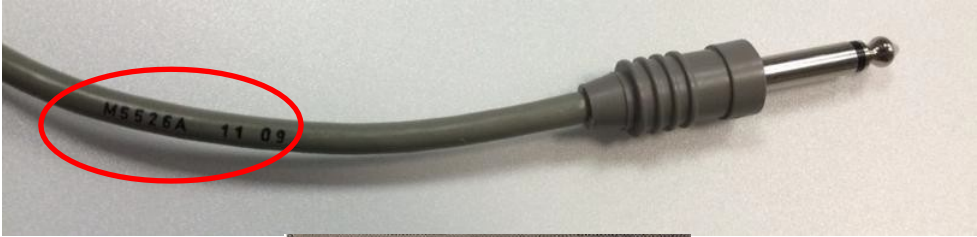
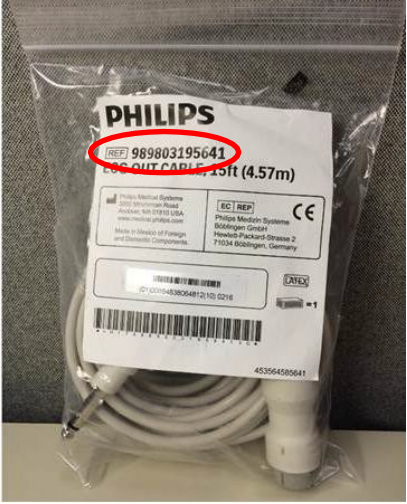
<p><b>HOW TO IDENTIFY AFFECTED PRODUCTS</b></p>	<p>Philips M1783A/M5526A sync cables and 989803195641 ECG out cable identified above are affected by this issue.</p> <p>The model numbers are printed on the outside of the cable, near the end with the ¼” phone plug and on the bag label.</p>

<p><b>ACTION TO BE TAKEN BY CUSTOMER / USER</b></p>	<p>Customers should remove affected sync cables and ECG out cables from service and destroy them, documenting such action on the attached reply form, which should be returned to Philips. Customers should retain a copy of the reply form.</p> <p>The customer should follow the Instructions for Use that describe the recommended approach for performing cardioversion with the XL+ and MRx monitor/defibrillators. The ECG trunk cable can be disconnected from the Philips bedside monitor and connected to the monitor/defibrillator before delivering therapy; this is the preferred source of an ECG waveform for synchronization.</p>
