Urgent Field Safety Notice

Regarding **ProteusPLUS** and **ProteusONE**

GENERAL INFORMATION	
SUBJECT	Pencil Beam Scanning system cannot detect dark current from cyclotron
IBA REFERENCE	Problem Report PR-83365
INFORMATION ON AFFECTED DEVICE(S)	
PRODUCT	Proteus 235
BRAND NAME	ProteusPLUS and ProteusONE
COMPONENT	Beam Management System
SOFTWARE VERSIONS	all
MODE	Pencil Beam Scanning
CONFIGURATION	Cyclotron C230
SERIAL NUMBER	PAT.000, PAT.003, PAT.006, PAT.107, PAT.108, PAT.109, PAT.111, PAT.112, PAT.113, PAT.114, PAT.115, SAT.116, SAT.117, SAT.119, SAT.120, SAT.122, SAT.123, SAT.126, SAT.132, SAT.133
REASON FOR FIELD SAFETY NOTICE	
DESCRIPTION OF THE PRODUCT PROBLEM	<p>It has been observed during testing that there could be clinically non-negligible amount of dark current in Pencil Beam Scanning (PBS) treatment mode when system is not irradiating between layers. Dark current is a well-known physics effect observed in cyclotron.</p> <p>This issue has only been observed when the cyclotron parameters¹ are not optimized. In that case, the dark current value could go up to 5cGy/s at maximum energy. Beyond that value, the safety checks present in the system will stop the irradiation.</p>

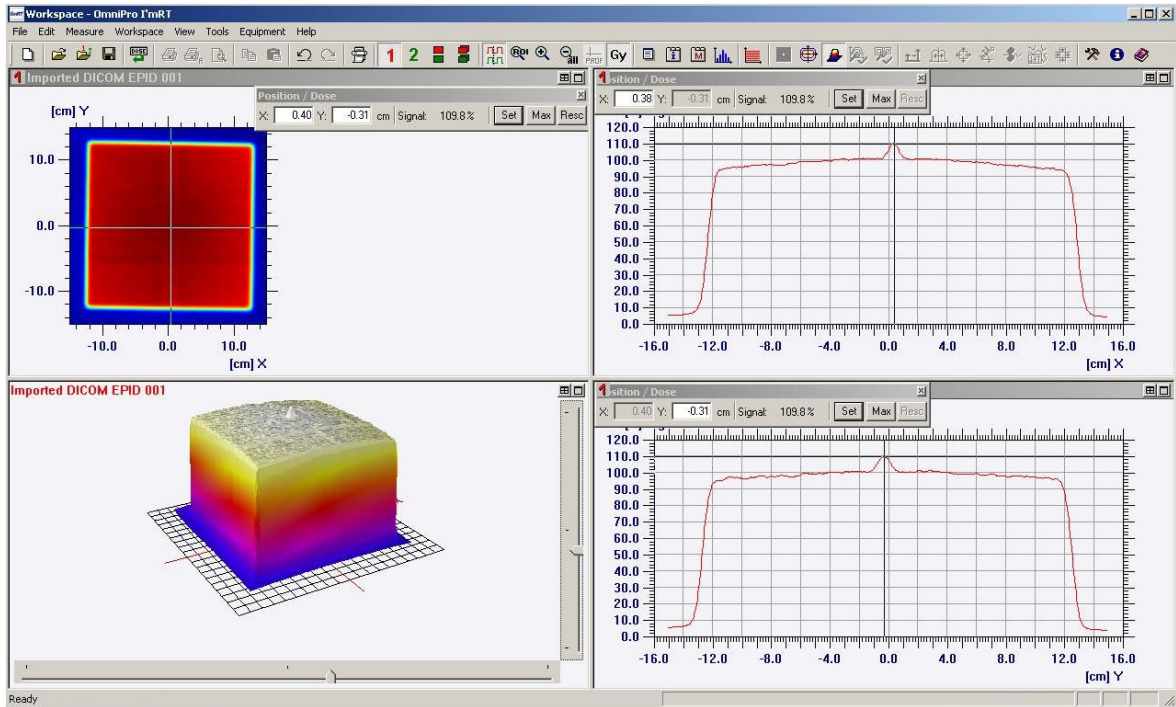
- Run the “Dark Beam” QA Map² with the LYNX dosimetry tool at maximum energy,
- If there is a peak in the center of the beam profile as shown on Figure 1:
 - o Confirm it is due to dark current by running the same QA Map at the lowest energy (if there is no peak, it is most probably due to dark current),
 - o Contact IBA to analyze and fix the issue.

Figure 1 - Peak in the center of a beam profile due to dark current. Here the peak value is 110% of the dose but it could be a higher or lower value depending on the intensity of the dark current.

In case a peak is observed on the beam profile, it is suggested to open a downtime event until the dark current issue is fixed.
