Urgent Field Safety Notice

Single Chamber Temporary External Pacemaker 53401

June 2018

Medtronic reference: FA824

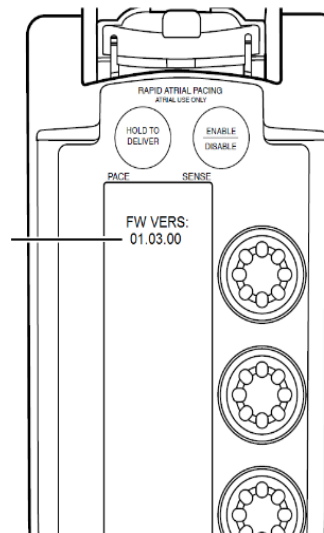
FIGURE 1- updated firmware displayed in this image

During power up process, Firmware Version will be displayed for 2 seconds

1. Verify whether 53401 EPGs in your possession are affected
2. If your EPG is affected, complete the following:
 - o Determine if the EPG firmware has been updated.
 - Power unit on and view firmware version (Figure 1 below).
 - If firmware version is 01.03.00 or greater, EPG firmware has been updated with correction for this issue. No other action is recommended.
 - If firmware version is 01.02.00, EPG firmware has not been updated. You may arrange to have your Medtronic Service Center update the EPG firmware at no charge.
