Urgent Product Correction Notice

Our Ref: 4215 FSCA VITEK® 2 – Integrity of the Card Pouch

FSCA 4215 : VITEK® 2 – Card Pouch Integrity

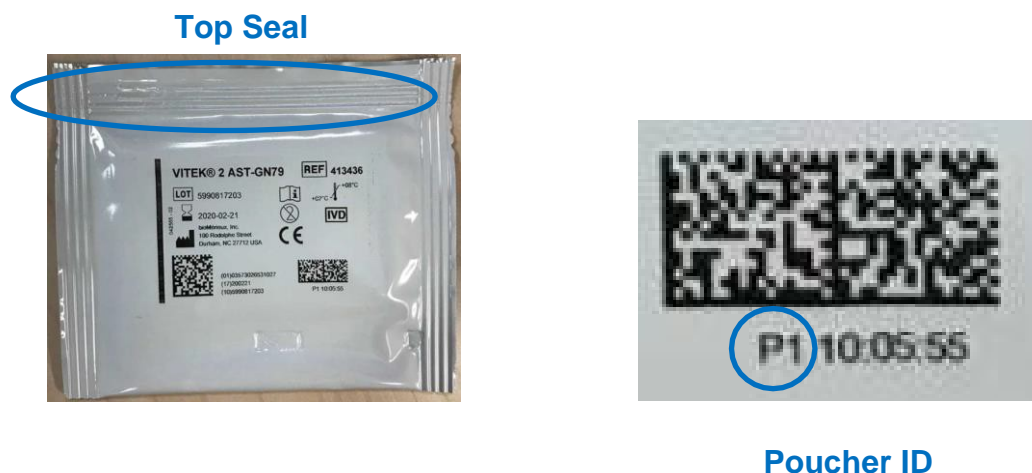
Figure 1: Top Seal and Pouch ID

A potential issue was identified related to the top seal of card pouches containing the VITEK® 2 test cards for the product lots specified in Appendix A. bioMérieux has determined that the integrity of some of the VITEK® 2 test card top seal may be compromised (see Figure 1). Based on our investigation, a compromised test card top seal can impact card reagents due to the entry of moisture.

bioMérieux investigation concluded that the pouch top seal of the card lots manufactured on a specific card poucher (Pouch 1) between 10Aug2018 and 29Aug2018 is potentially compromised. A small section of the top seal may be improperly sealed for the card lots indicated in Appendix A.

1. As VITEK® 2 ID/AST cards may be pouched on different pouching equipment in manufacturing, confirm the card was pouched on Poucher P1 and determine if a P1 indication is present (Figure 1). Cards that have other identifiers, such as P2, P3, etc. are not impacted.
2. Grasp the card pouch so the top seam is facing you.
3. Apply a modest pulling force to each side of the top edge of the pouch, at three (3) separate points as shown in the images below.
