Subject: Urgent Field Safety Notice Software Update – Minute Ventilation Sensor Software Update Available for Pacemakers (see previous communication issued in December 2017 with reference 92186345-FA).

Summary Field Safety Notice (FSN)

Boston Scientific Software Update for MV Sensor Oversensing

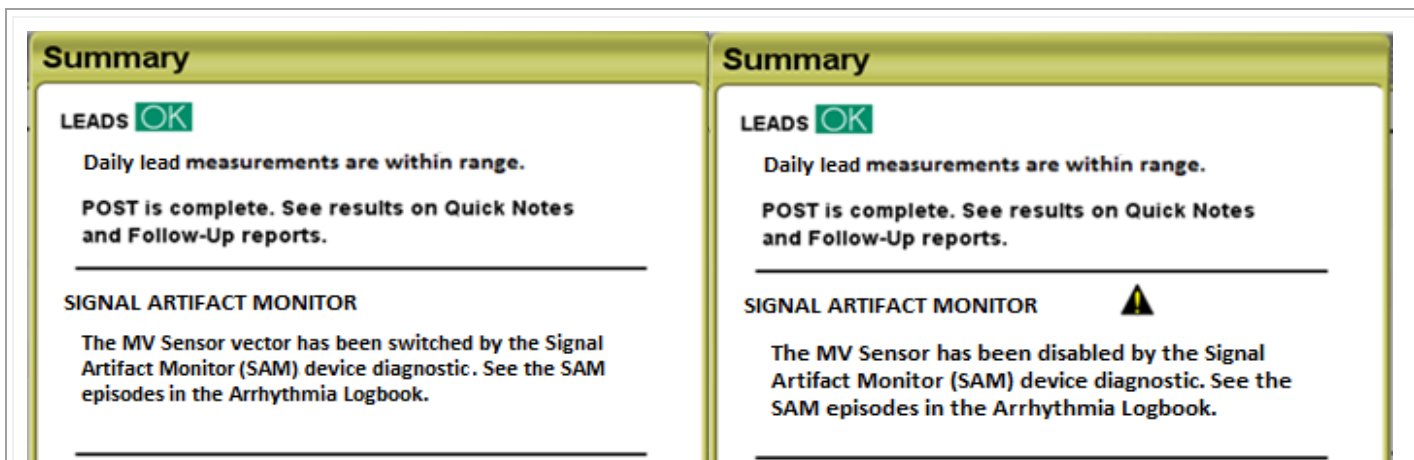
A disabled MV Sensor will remain in that state until manually reprogrammed. No MV rate-responsive pacing and no respiratory-related trending will occur while the sensor is disabled. At the next programmer interrogation, the user will be notified of any SAM events (see Figure 1) with associated episodes available within the arrhythmia logbook for review. A future LATITUDE NXT Remote Patient Management system release will enable the user to view SAM parameters/episodes and receive a yellow alert if SAM disables the MV sensor.

Figure 1. Summary dialogue presented at the next programmer interrogation after the MV sensor vector has been switched or MV disabled by the Signal Artifact Monitor.

4. If the MV sensor is disabled by the SAM, evaluate lead integrity and lead connection before re-programming the MV vector or programming the MV sensor to ON, Passive, or ATR Only. SAM episode data may assist in determining the source of transient impedance conditions. Contact Technical Services to explore all non-invasive programming options prior to surgical intervention if transient, abrupt changes in impedance measurements, or out-of-range impedance measurements are observed.
