URGENT – Field Safety Notice

Bent pedal of footswitch might cause interruption of live Fluoroscopy imaging or exposure.

A problem has been detected in the Philips MultiDiagnost-Eleva with Flat Detector and Allura Xper systems that, might intermittently lead to interruption of live fluoroscopy imaging or exposure.

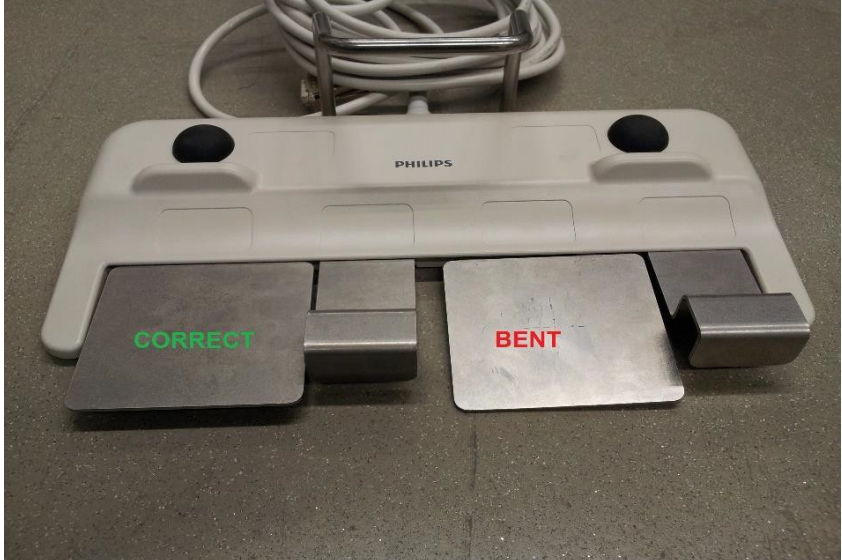
Philips noticed that due to a bent pedal of the footswitch, loss of image functionality is possible (intermittent or continuous inability of making live fluoroscopy images or exposures). The pedal may get bent when the footswitch is frequently used on an anti-fatigue mat or on a not flat surface or in the pedestal.

<p><i>Left pedal is correct. Third pedal from left is bent. Distance to floor should be approx. 12mm (0,47inches).</i></p> <ul style="list-style-type: none"> • Do not use the footswitch on an anti-fatigue mat or in the pedestal. • Please ensure that all staff with access to the affected systems are informed of the content of this Field Safety Notice. • Include this Field Safety Notice together with the documentation of the system until the system has been corrected by Philips.
<p>ACTIONS PLANNED BY PHILIPS</p>	<p>The problem will be resolved by an update of the mechanical hardware of the Footswitch that will prevent that the pedals of the footswitch becoming bent.</p> <p>This mechanical hardware is available by February 2019.</p> <p>You will be notified by your local Philips representative to schedule a date for installation of this mechanical hardware update.</p>

<p>ACTION TO BE TAKEN BY CUSTOMER / USER</p>	<ul style="list-style-type: none"> • Before the start of a procedure, the user must check the footswitch for possible bent pedals. See images below on how to identify a bent pedal. If bent pedals are found the procedure should not continue and Local Service should be contacted.
