# Urgent Field Safety Notice

## SBN-SIS-2019-002

### Loose screws on the Tray Input Flap of the cobas p 501 /p 701 post-analytical units

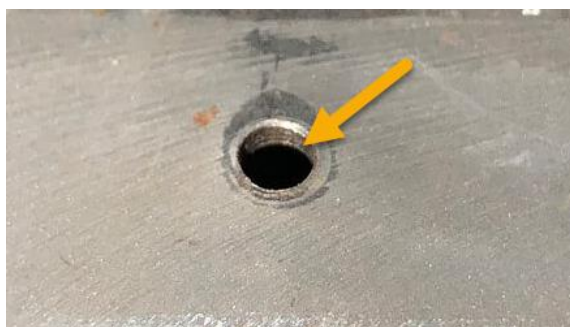
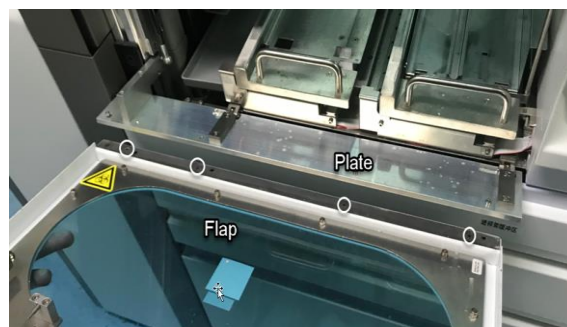
The Tray Input Flap screws can become loose on the cobas p 501 or p 701 post-analytical units resulting in the potential detachment from the instrument.

Visual inspection of the Tray Input Flap, plate and screws were performed. As demonstrated in the pictures below, the flap was no longer attached to the instrument and the 4 M3 threads on the Tray Input Flap were worn out resulting in the screws not working as intended.

The Tray Input Flaps on instruments with the above listed serial numbers must be replaced by Roche Diagnostics with the current design of the tray input flaps with an estimated completion date of 30-September-2019.

Prior to the replacement tray input flaps being installed, customers must be informed that they should always inspect their tray input flap to ensure the tray input flap is securely attached to the instrument. If the flap is not fastened securely or becomes loose prior to the tray input flap being replaced, they must contact Roche Diagnostics to repair the instrument.
