Safety Advisory Notice SY015/19/S

syngo.CT Cardiac Function
used in *syngo.via* VA20A, VA30A or VB10A
syngo.CT Cardiac Planning
used in *syngo.via* VB20A or VB30A

Subject: *syngo.CT* Cardiac Function / Planning – Risk of wrong measurement in the annulus-plane

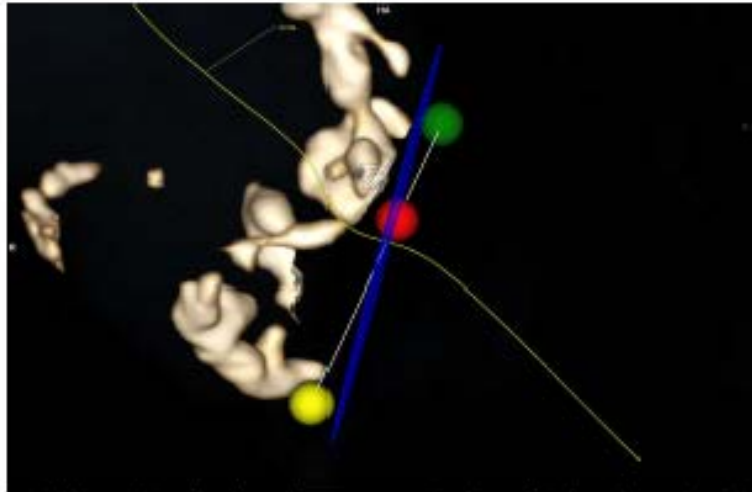
During the automatic procedure a smoothing algorithm subsequently adjusts the shape of the centerline. In unfavorable conditions this smoothing algorithm can result in a slight distortion of the centerline and ultimately in a tilting of the measurement plane compared to the previously defined annulus plane. Any measurements of annular parameters taken under the described conditions might be incorrect due to the tilted measurement plane.

When evaluating the annular dimensions the operator has to ensure that the measurement plane is optimally aligned with the annulus plane. This can be checked in the VRT segment as shown in Fig. 1. For this check, the operator has to move to the annulus plane by pressing the button "Annulus Plane". By activating the vessel diameter measurement tool a blue measurement plane will be displayed and can be compared with the white annulus plane. If they are not aligned, as seen in Fig. 1, any measurements using the cross-sections of the curved planar reformation may not be accurate.

Fig. 1: VRT segment with angular misaligned measurement-plane (blue) and annulus-plane (white) in a worst case situation

Important: If the operator recognizes a significant deviation of two planes as shown in Fig. 1, it is absolutely essential to avoid any measurements in the CPR segments using the cross-sections at the annulus plane.

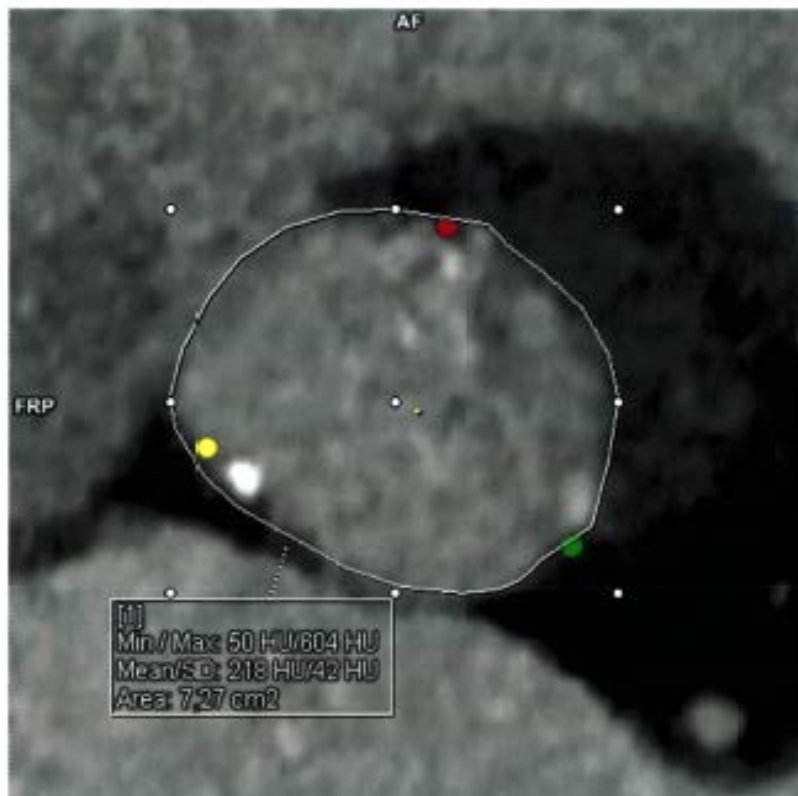
Fig. 2: MPR example for correct manual measurement using the function "ROI Polygonal Measurement"

Workaround: As shown in Fig. 2 any annular measurement shall be performed manually in the MPR segment showing the annulus plane instead. The ROI Polygonal and/or Distance Line tools can be used.
