Field Safety Notice

2019-APR-17 | REF-MSA-2019-001-IU|

Subject: Cracked coating fork on VOLISTA light

Products affected: All Getinge VOLISTA light head of model STANDOP and TRIOP manufactured until July 2017

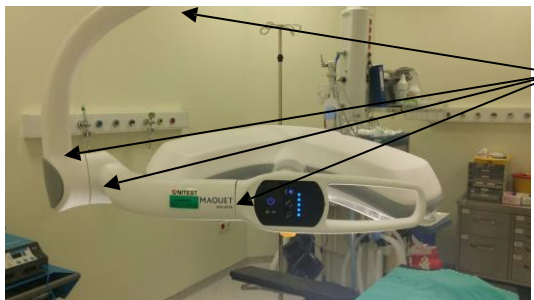
Under certain conditions, we have identified an issue that might prevent the device from performing as intended. Maquet SAS, the manufacturer, received some complaints regarding light head fork (yokes). It was established that the coating of those forks might show cracks. Therefore, there is a risk that particles may fall and generate infection. Maquet SAS didn't received any adverse event (i.e. infection) regarding this issue.

- The coating cracks can be observed on both side of each fork, as you can see on the pictures below:

4 possibles locations of cracks

If you detect a coating crack on the fork, please STOP USING the device and contact your Getinge representative.

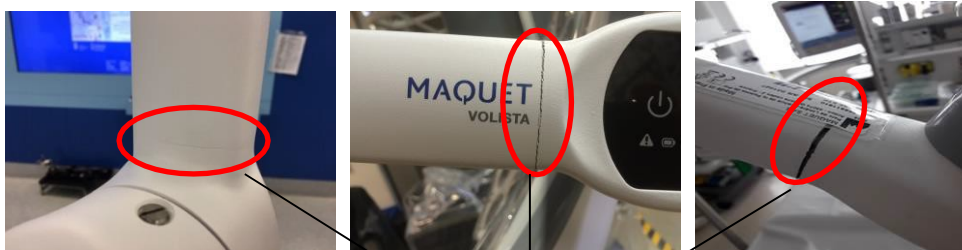
- The coating cracks can be different size, as explained below:

Pictures of the coating crack with different size
