## **URGENT - Field Safety Notice**

### **Medical Device Correction**

### **Ingenuity CT, IQon Spectral CT, iCT, Brilliance 64 CT, Ingenuity TF, Vereos Step and Shoot Incorrect Image Phase Labeling**

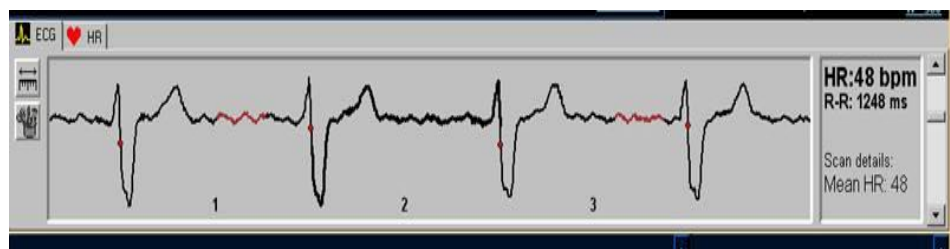
3.x Graphical User Interface example

This issue affects all systems listed above (with the exception of Vereos) with 4.x software and all iCT systems with 3.x software. Images can be reconstructed with phase tolerance by performing an offline reconstruction of the raw data. No patient rescan is required.

- How to avoid in 3.x: Wait until the ECG strip is visible at the bottom of the acquisition window to starting the reconstruction.

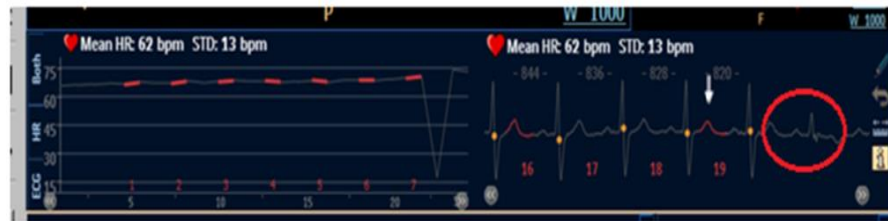
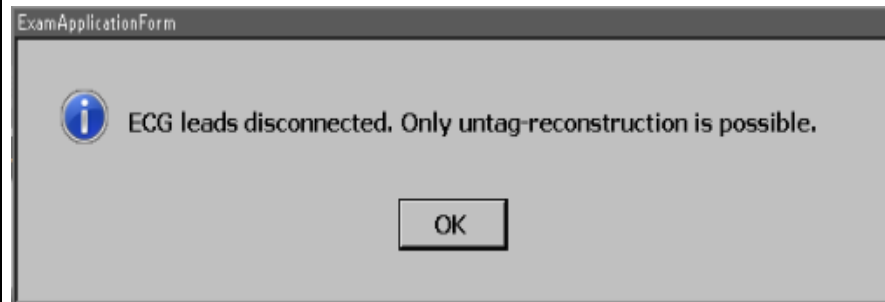
- This can occur with version 4.x software

- Should this occur, the user will receive the following console message:

- Images will be incorrectly labeled as if phase tolerance has been applied, however, the images will be reconstructed without phase tolerance.
- How to avoid: Ensure that the leads are securely attached to the patient prior to starting the acquisition and the length of table travel allows the leads to remain securely attached through acquisition completion. In the event of an application crash, there is no way to avoid the issue.
- When this issue occurs, images may still be used but are not labeled with the correct ECG phase. If images with phase tolerance are needed, a rescan may be required.

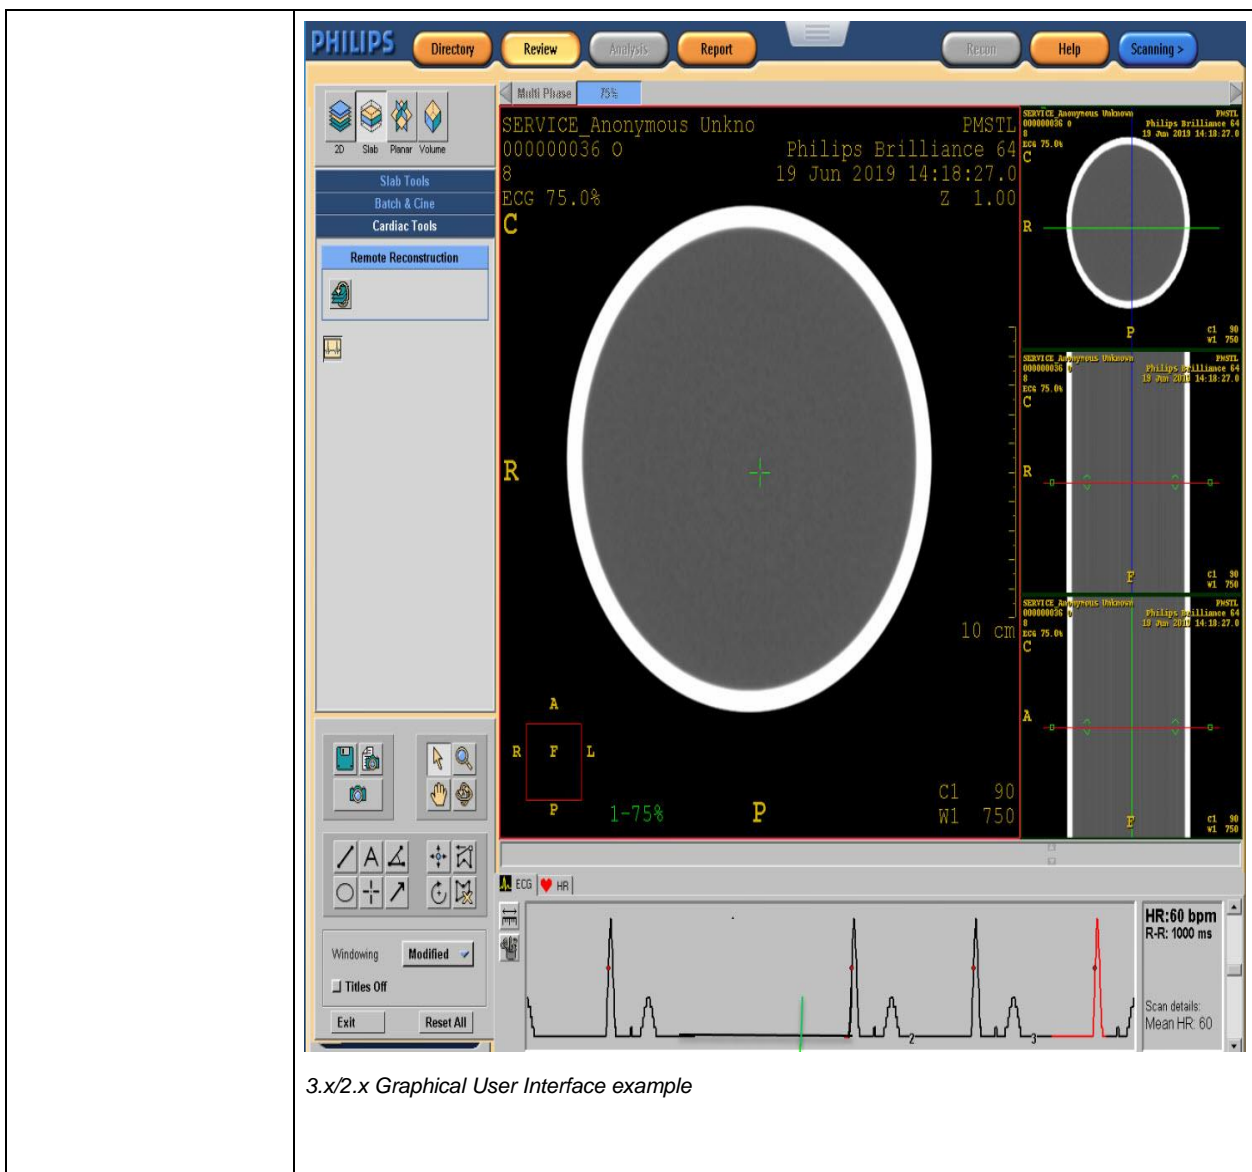
4.x Graphical User Interface example

3. In some instances, when a patient exhibits an arrhythmia or varying heart rate during a Step and Shoot acquisition, images from the acquisition following the heart rate variation, may be labeled in the incorrect phase.

- This is by system design. In cases where the heart rate changes or an arrhythmia occurs, the white arrow/green line in the ECG display is not aligned on top of the acquisition.
