Urgent Field Safety Notice for: Dako Autostainer Instruments (AS480; AS100; S3800; S3400):

Update of Autostainer Link Basic User Guide to reduce risks of staining issues due to leakage

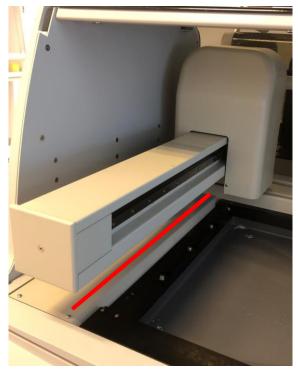
Visually inspect the syringe tray, syringe and stopcock, areas highlighted in red, for signs of unexpected leakage (salt residues and/or liquid).

If there are signs of unexpected leakage (salt residues and/or liquid), contact your local Technical Service representative immediately as this might indicate a leakage in the system.
