syngo.via RT Image Suite
with syngo.via VB30 and syngo.via VB40 software
with licence for patient marking with external lasers
(technical name of the license:
"CTRRT IMAGE SUITE PAT MARK")

Customer Safety Advisory Notice SY051/20/S

SOMATOM go. CT Scanners with
syngo.RT Image Suite
with syngo.CT VA20A, syngo.CT VA30A
with licence for patient marking with external lasers
(technical name of the license:
"CT RT IMAGE SUITE PAT MARK")

Subject: Incorrect calibration offset between CT central image plane and external lasers after update/upgradepotentially resulting in an unprecise cancer treatment

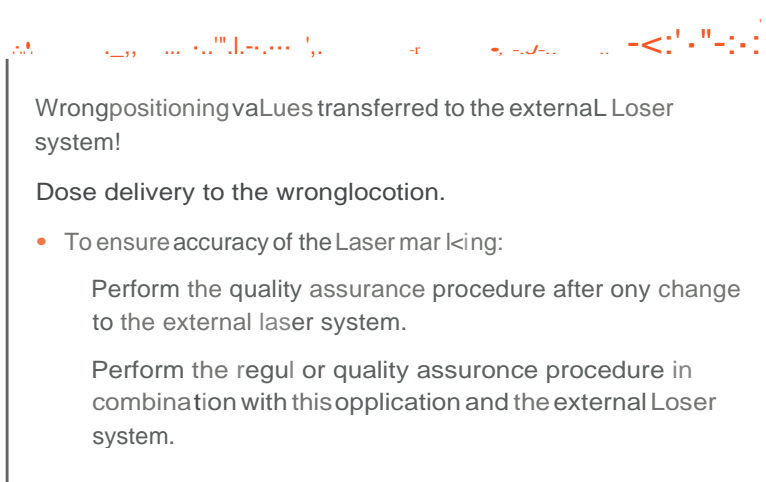
Figure 1: Warning on page 28 (English version) of user manual *syngo.via RT Image Suite* (Print No. C2-via-RT.621.03.03.02)

In addition to the already provided recommendation in your user manual (see warning in Figure 1 below), we highly recommend performing the laser calibration and the quality assurance procedure for the laser offset after every RT Image Suite software update.

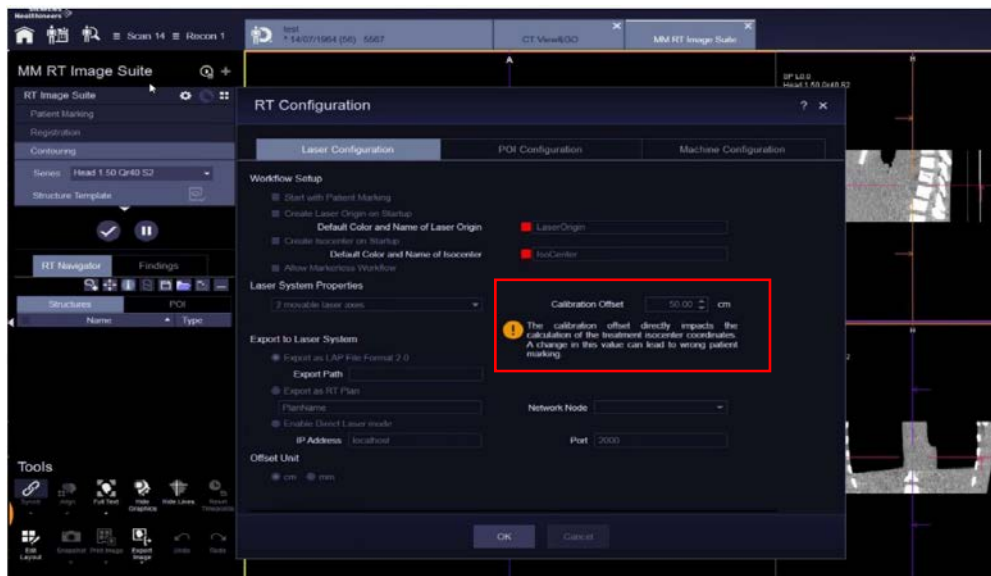
The calibration offset between the central CT image plane and the external RT lasers has been set automatically to the factory default of 50.00 cm, if your syngo.via RT Image Suite has been updated or upgraded to one of the following software versions:
- syngo.CT VA20A to syngo.CT VA30A
- from any lower syngo.via SW-version to syngo.via VB40

Figure 2: MM RT Image Suite Configuration dialog with the marked parameter

Please update the calibration offset in the MM RT Image Suite Configuration dialog accordingly as shown below in Figure 2. Details of this procedure are documented in Chapter 13.2 (Laser configuration) of your user manual.
