Customer Safety Advisory Notice CAN 001-2020

Re: Symbia S and Symbia T system unintended detector motion

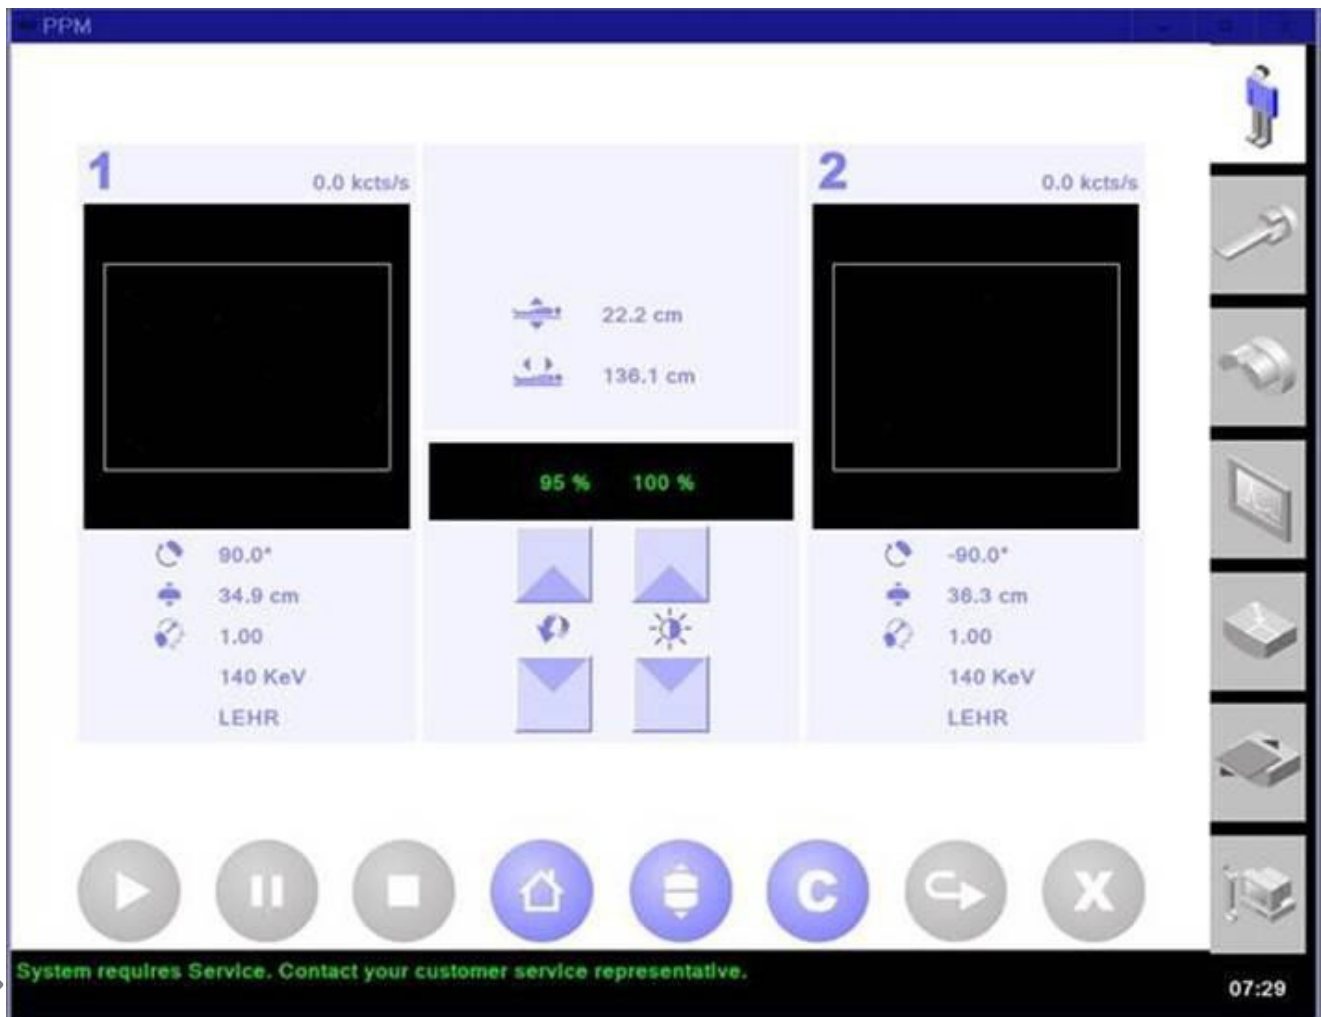
If unintended detector motion is observed, downward pressure from the detector is reported by the patient at any time or the PPM presents a system error (as shown in the picture below), then manually retract the patient from the gantry using the patient bed handle and release button, stop use of the system and contact your customer service representative.
