URGENT: Medical Device Field Safety Notice
 IMPORTANT INFORMATION

To: Distributors / Resellers/ Hospital Professionals
Date: 14th of September 2020
REF: CAPA-2020003

Bien-Air Surgery SA, manufacturer of OSSEODUO/OSSEOUNO/OSSEODOC/OSSEOSTAP control units, has initiated a **Field Safety Corrective Action** affecting devices that you may have in stock or may have further distributed in your territory. The details of this action are specified below.

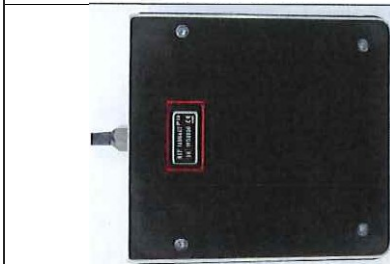
On the bottom

Where to find the foot pedal's reference and serial number s:

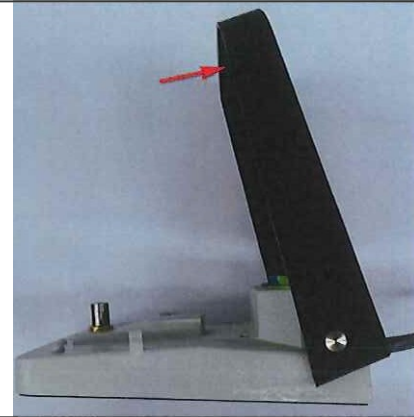
This field safety corrective action has been initiated because there is a low possibility that the magnet located inside the foot pedal displaces or comes off during a surgery and therefore may compromise the device's safety.

- 1) Inspect your inventory for the product numbers/serial numbers above.
- 2) Quarantine any of the affected products until performing the following actions
- 3) Open the foot pedal rocker to have access to the incriminated magnet by pulling the black part

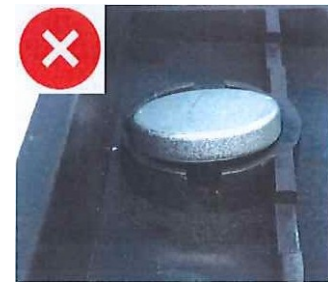
The magnet is well positioned The magnet is partially off or moves when pressing The magnet is fully off

- 4) Carefully inspect the position of the magnet using the below illustration. When slightly pressing on the magnet, it shouldn't move.

Continue with action N°5

KEEP THE FOOT PEDAL IN QUARANTINE (DO NOT USE IT ANYMORE), contact your local representative for Bien-Air Surgery products who will organize the repair

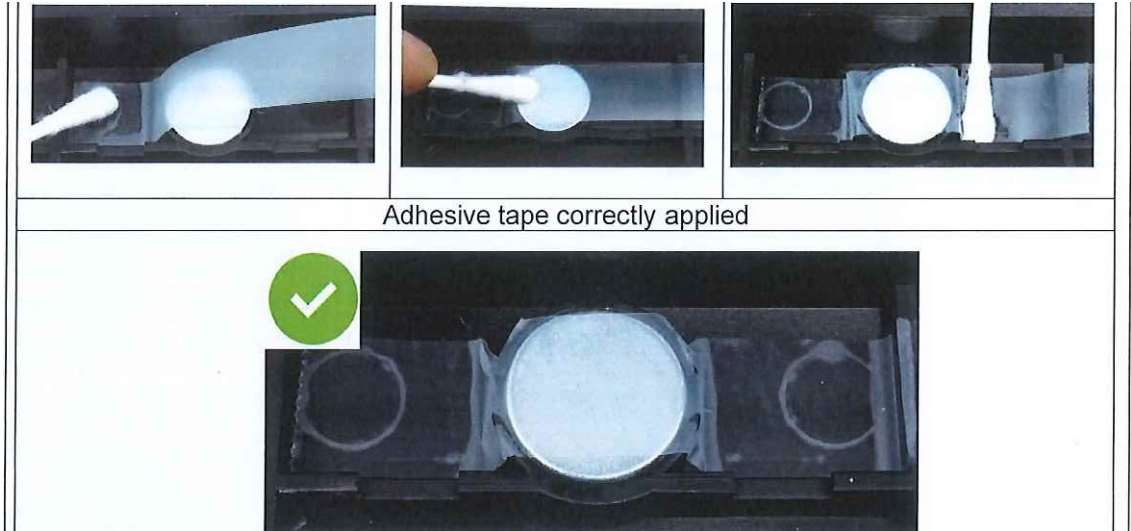
Adhesive tape correctly applied

- 6) Make sure the surface is clean and dry before applying an adhesive tape (e.g. Scotch®, width between 10-15mm, length between 55-60mm) as described below

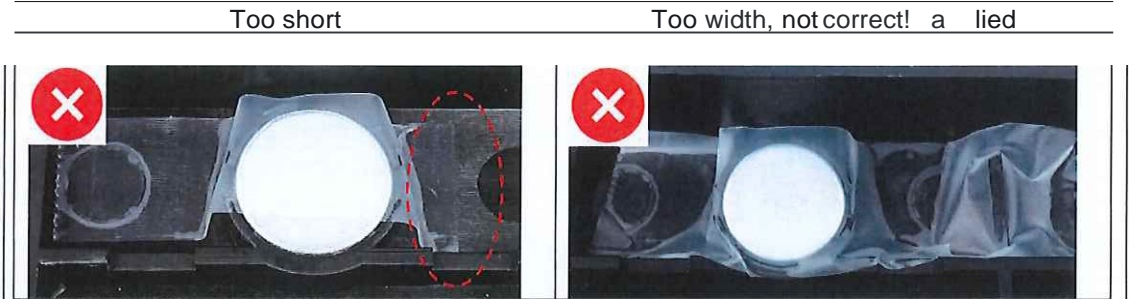
Too short

Too width, not correct! a lied

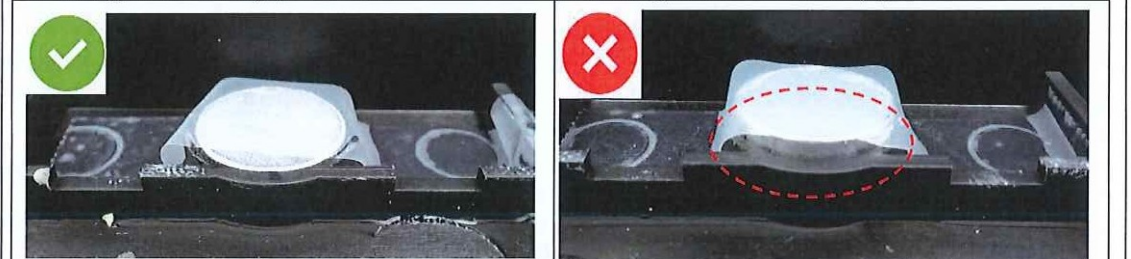
The adhesive tape is correctly applied and the magnet correctly positioned

The adhesive tape is correctly applied but the magnet NOT correctly positioned

- 7) Carefully inspect that the adhesive tape is correctly holding the magnet and that the magnet is still correctly positioned. If needed, remove the tape and restart the process from step 4.

Continue with action N°8

KEEP THE FOOT PEDAL IN QUARANTINE (DO NOT USE IT ANYMORE), contact your local representative for Bien-Air Surgery products who will organize the repair
