Urgent Device Correction

Elevated Temperature of Receive Coil Components When Using Select Ciné Treatment Imaging Sequences

UDC 2020-001

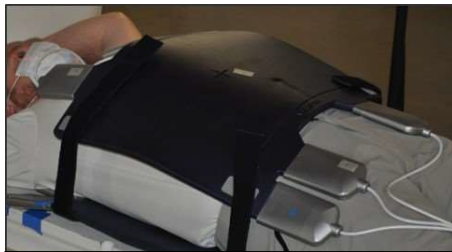
The extreme testing conditions showed that the use of 3 Plane or 8 fps cine' treatment imaging sequences while the receive coil is positioned close to the bore wall causes some of the gray plastic electronic boxes ("feedboard boxes" Figure 1 & 2) attached to the receive coil, to reach an elevated temperature. If the feedboard boxes are in contact with the patient or user, there is the potential risk of injury.

During radiation delivery, the MRIdian system continually acquires images. During this continuous imaging, the receive coils are exposed to RF energy. The amount of RF energy exposure is directly related to the cine' treatment imaging sequences being used. The higher RF energy associated with the 3 Plane and 8 fps sequences and the proximity of the coil to the bore wall contribute to the elevated temperature of the feedboard boxes.

Figure 1: Torso coil with feedboard boxes oriented toward feet

Safety is a core tenet of ViewRay's quality policy. ViewRay's highest priority is to resolve these issues immediately. We will provide an update to customers when new information is available. Until that time, customers should use 4 fps imaging sequences instead of 8 fps imaging sequences and follow the guidance when using 3 plane imaging.

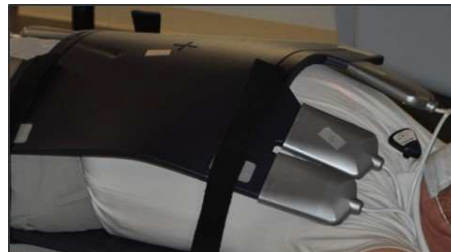
Figure 2: Torso coil with feedboard boxes oriented toward head

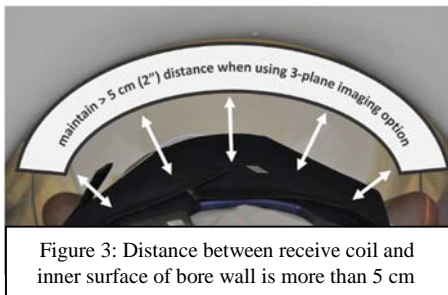
Figure 3: Distance between receive coil and inner surface of bore wall is more than 5 cm

Do: Maintain a distance of at least 5 cm (~2") between the receive coil and the inner surface of the bore wall when using 3 Plane ciné treatment imaging (Figure 3 & 4).

Do Not: Select 3 Plane ciné treatment imaging if a distance of at least 5 cm (~2") cannot be maintained between the receive coil and the inner surface of the bore wall during treatment.
