Customer Safety Information (CSI) for Field Safety Corrective Action: AX014/20/S

Subject: Field Safety Notice for: Exchange of a printed circuit board (“main control D80” with revision less than 04) which is included in certain Cios Spin & Cios Alpha systems.

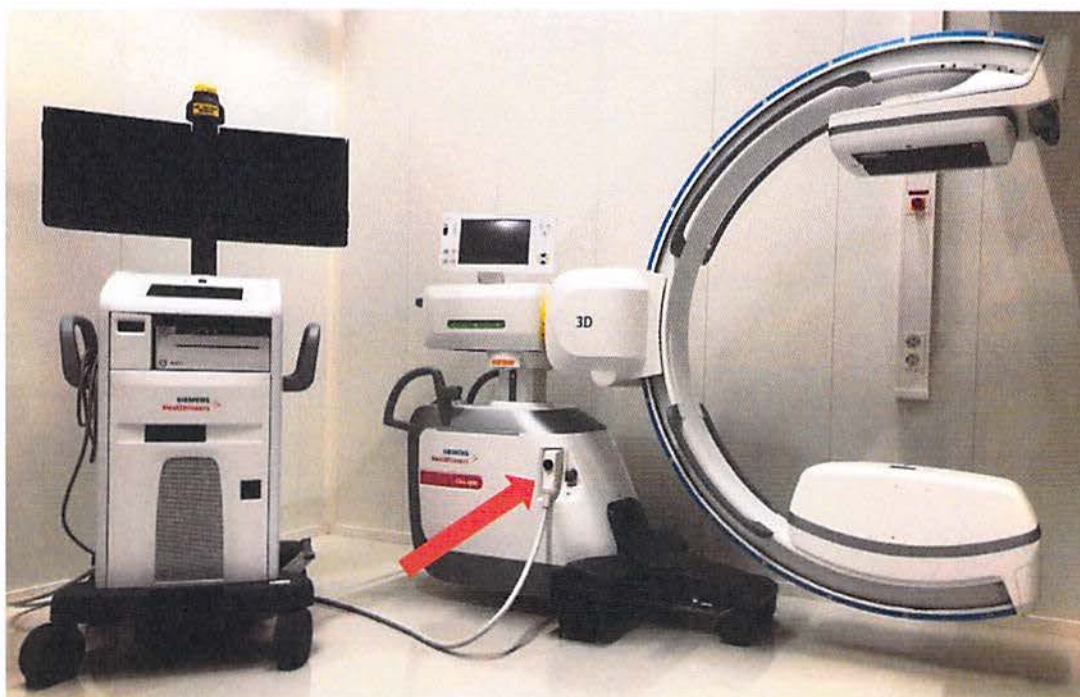
Our Cios systems offer a “hot plugging” feature between trolley and main unit (c-arm). The “hot plugging” feature enables the clinical user to plug/unplug the X10 connector of the main cable (please refer to figure 1 below) at any time during clinical session, provided that the system is electrically connected and powered on. In very few cases the “hot plugging” feature could cause an electrical malfunction on the main control D80 of the generator which is part of the main unit (c-arm).

figure 1: example of X10 connector with main cable, connected to Cios Spin c-arm

The subject was identified during a demo session when application engineer wanted to perform the “hot plugging” feature of a Cios Alpha VA30 system. The root cause is a design flaw in the component main control D80 with revision less than 04.

We advise urgently to cease the use of the above-described “hot plugging” feature until the pending hardware update AX014/20/S has been completed.

A service engineer will replace the main control D80 of your affected system by a revised main control.
