! IMPORTANT SAFETY NOTICE

October 29, 2020

Subject: Auto-Field Sequence workflow fails to prevent treatment after isocenter is lost during setup.

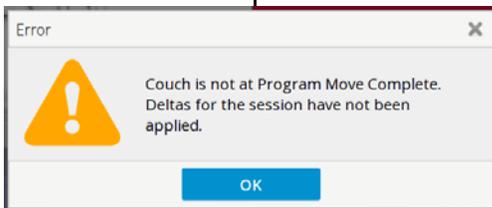
In the event that a user action causes isocenter to be lost during the setup workflow, the system will present error messages on the In-Room Monitor and the TC screen indicating that Deltas were not applied during setup or a Program Move Complete (PMC) was not achieved. When the Setup field is closed another Error Message (see below) appears on the TC that informs the user of a problem which they must correct. The user is prevented from proceeding to a treatment field until the setup is corrected and the Setup field is closed with a PMC.

Auto-Field Sequence should not be used until the underlying defect is corrected.

- **Site physics should assure that Auto-Field Sequence is not used**
- **Therapists should not select the check box for Auto-Field Sequence**
- **Field service engineers have been notified to not set Auto-Field Sequence as the default configuration.**

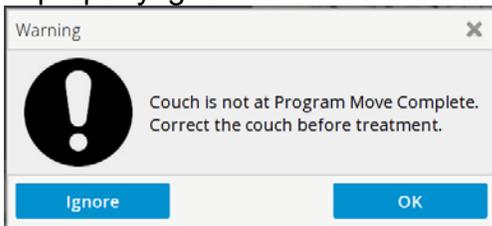
The Auto-Field Sequencing option as currently implemented, automatically loads the first treatment field after the above Error Message is acknowledged. The workflow is permitted to proceed to treatment. Additional Warnings (see below) will appear before each beam can be turned on, but those warnings may be improperly ignored.

If the incomplete move and lost isocenter puts the patient a significant distance away from the prescribed position, a misadministration due to a geographic miss is possible.
