Dringende veiligheidskennisgeving

Fout in Intellis™-gegevensvalidatiesysteem

Software-update van model A710 naar versie 1.3.130

Medtronic-referentienr: FA949

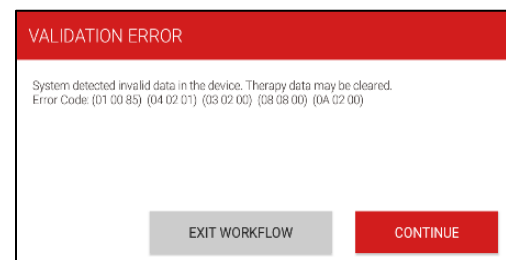
Afbeelding 1: Prompt van validatiefout

Medtronic heeft tussen januari 2020 en 24 november 2020 veertien (14) meldingen ontvangen van gebruikers die deze validatiefout (Afbeelding 1) gevolgd door een systeemfout (Afbeelding 2) ondervonden op het CT900 Artsenprogrammeerapparaat met de A710 Intellis-softwaretoepassing versie 1.3.80 met als vermelding dat de update voor het programmeren van de stimulator niet kon worden voltooid. Na onderzoek werd vastgesteld dat er sprake was van beschadiging binnen een bepaalde locatie van het stimulatorgeheugen en dat de A710 Intellis-softwaretoepassing versie 1.3.80 de beschadiging niet conform het ontwerp vrijgaf, resulterend in een systeemfout. Deze systeemfout treedt niet vaak op en de gerapporteerde frequentie waarmee de fout optreedt is minder dan 1 op 10.000.

Als u wordt geconfronteerd met de VALIDATION ERROR (Validatiefout) (zoals geïllustreerd) met foutcode (01 00 85) (04 02 01) (03 02 00) (08 08 00) (0A 02 00) **voordat** u de meest recente A710 Intellis-softwaretoepassing v1.3.130 installeert, selecteert u de optie "**CONTINUE**" (Doorgaan). Als "**EXIT WORKFLOW**" (Workflow afsluiten) wordt geselecteerd, brengt u de communicatie opnieuw tot stand en selecteert u "**CONTINUE**" (Doorgaan) wanneer u wordt geconfronteerd met de VALIDATION ERROR (Validatiefout) (Afbeelding 1).

Download de meest recente update van de A710 Intellis-softwaretoepassing, versie 1.3.130, naar het CT900 Artsenprogrammeerapparaat volgens de bijgevoegde instructies.

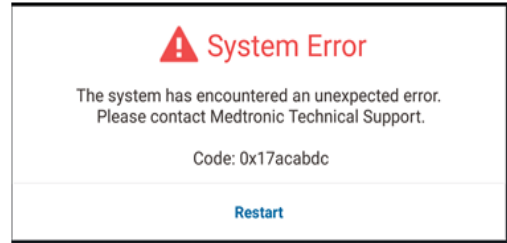
Afbelding 2: Prompt met systeemfout

Als, na het selecteren van de optie "**CONTINUE**" (Doorgaan), deze "**System Error**" (Systeemfout) (Afbelding 2) wordt weergegeven, neemt u contact op met uw Medtronic-vertegenwoordiger of met Medtronic Trading NL BV op 040-7117555 voor hulp met het downloaden van de meest recente A710 Intellis-softwaretoepassing v1.3.130. Breng na het downloaden van de meest recente Intellis-softwaretoepassing v1.3.130 de communicatie opnieuw tot stand en selecteer "**CONTINUE**" (Doorgaan) om dit probleem op te lossen.
