URGENT: Field Safety Notice

MOD1329

WelchAllyn GS777 Wall Transformer (all models) and PROBP 3400 (handheld, desk mount, wall mount models)

Subject: GS777 Wall Transformer and ProBP 3400 Potential Fluid Ingress (MOD1329)

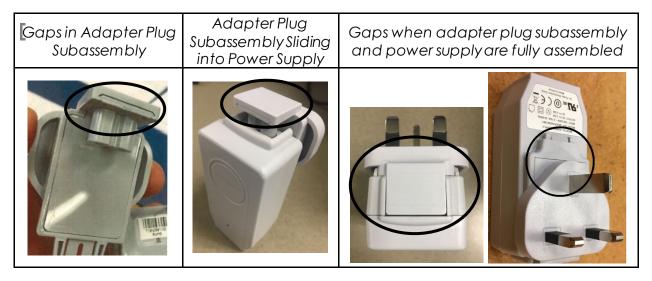
There is a risk of an internal electrical short and possible electrical shock occurring if cleaning fluid ingresses into the power supply, and the power supply is plugged into the electrical outlet before the cleaning fluid has completely dried. This notice is being distributed to make users aware of this potential risk and provide instructions for appropriately cleaning the power supply. The WelchAllyn GS777 is a device that is mounted either on the wall or on a mobile stand. It holds and supplies power to small handheld devices such as ophthalmoscope and otoscope heads. The ProBP 3400 Blood Pressure Device (all models) is a digital blood pressure device that can be used in a handheld, wall-mounted, or mobile configuration.

Our investigation has confirmed that the reported complaints were the result of unintentional fluid ingress into the power supply caused during cleaning.

Based on our investigation, unintentional fluid ingress is most likely to occur in the gaps of the adapter plug subassembly pictured below.

The GS777 and the ProBP 3400 power supplies are not intended to be cleaned with saturated wipes and should not be plugged into an electrical outlet when wet.
