## URGENT – FIELD SAFETY NOTICE

### Nimbus 4 & Nimbus Professional mattress – risk of over-inflation

**Field Safety Notice:** FSN-SUZ-001-2021

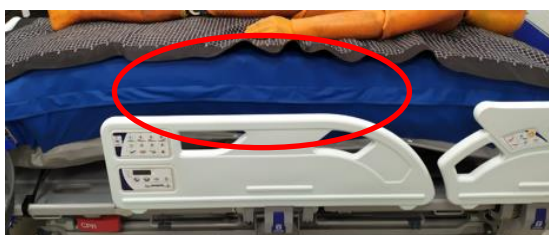
Arjo has received limited reports of the Nimbus 4/Professional mattress over-inflating which requires an unusual set of circumstances to occur. This is a very rare occurrence and there have been no reports of health consequences to either patients or caregivers due to this issue.

Our investigation has concluded that there is a remote possibility that a patient could fall from the mattress if the issue was to occur and was not detected by care givers. The issue is caused by inner mattress components that may fail after a certain period of time, however this is extremely rare and unfortunately cannot be detected until the product is disassembled.

Malfunctioning mattress

1. Transfer the patient to another appropriate surface
2. Turn off and unplug the pump.
3. Perform grommet membrane deactivation as instructed in the video to allow the accumulated air to freely vent out. Use a screw driver with a diameter of 2 – 3 mm. Make sure that the membrane is punctured through.

**NOTE: The grommet membrane restricts the volume of excess air escaping. Removing the membrane will not affect mattress functionality in any way other than to allow excess air to escape at a slightly higher rate. This process does not introduce any new risks.**
