**URGENT Field Safety Notice**

Trilogy EV300 and Trilogy Evo O2

July 2021

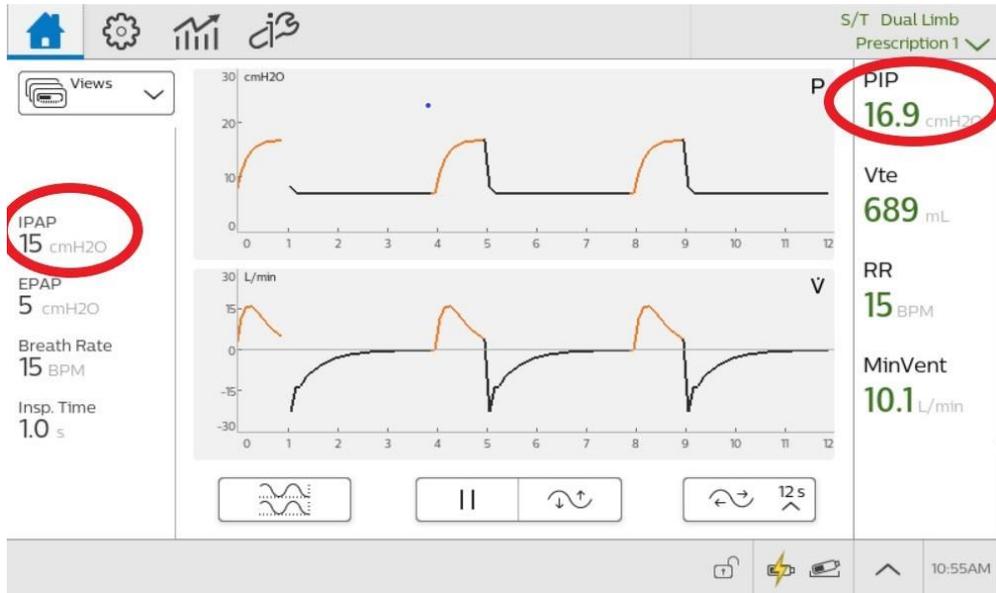
When a Trilogy EV300 or Trilogy Evo O2 model is used continuously without any interruption of therapy over weeks to months, the baseline pressure (that is, the pressure initially set for the patient) may increase or decrease at a rate of up to approximately 2 cmH<sub>2</sub>O per month. This increase applies to the PEEP and the inspiratory pressure at the same rate. The maximum pressure deviation that could be seen is a 10 cmH<sub>2</sub>O shift from the baseline pressure. The pressure regulation alarms will not annunciate with this issue.

The caregiver/clinician can detect the increase in pressure by observing the measured parameters on the device's screen (measured PIP value or pressure waveform as shown below where the IPAP is set to 15 cmH<sub>2</sub>O but because of the pressure increase the actual delivered pressure is 16.9 cmH<sub>2</sub>O).

**If a pressure drift is detected, the decision to reset the device and return to its original, intended settings MUST be made in consultation with a clinician. Take steps to support the patient during a brief interruption in therapy, as needed.**
