Hillrom™ Hillrom Luleå Nedre Vägen 100, 975 92 Luleå, Sweden	Field Safety Notice	FA 2021-05-002-LUL-003
---	----------------------------	-------------------------------

Field Action Identifier: FA 2021-05-002-LUL-003

Commercial name of affected product:

OctoStretch™ with Stretch Leveler, FlexoStretch™, Stretch Leveler, LikoStretch™ 1900, LikoStretch™ Mod 600 IC.

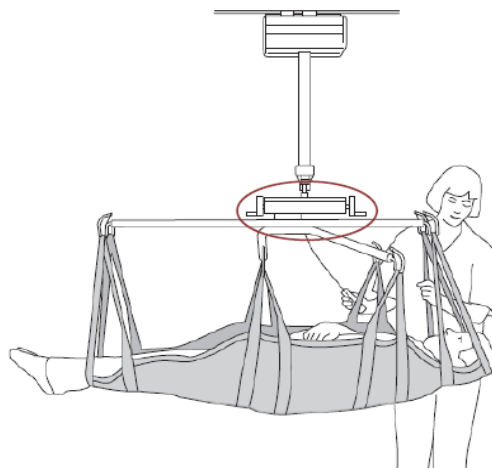
Figure 1

Hillrom has become aware of a user report of Leveler breakage used with the Octo Stretch.

As a result of the breakage the Stretch Leveler has the potential to lose the function of maintaining a patient in the horizontal position when lifting and in motion. When this function is lost the patient can slide backwards and potentially may fall out of the Oct lift sheet back onto the surface it is being lifted from. See Figure 1: OctoStretch with Leveler in use, Stretch Leveler circled.

Hillrom is replacing the stretch leveler to mitigate this risk of breakage. Upon completion of the enhancement(s), Hillrom will contact customers to coordinate update of the leveler device.

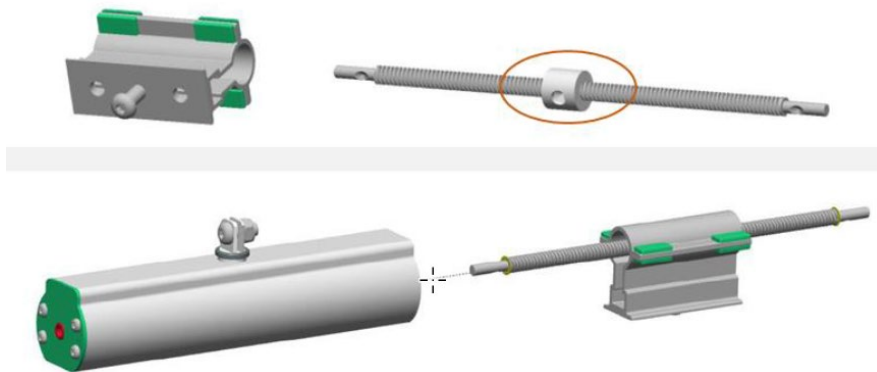
Figure 2

The function of the Stretch Leveler connected to the OctoStretch is to allow for adjustment of the center of gravity during lift. The Stretch Leveler is composed of a trapezoidal nut attached to an attachment profile on a threaded rod. If the trapezoidal nut breaks the leveler can shift center of gravity without the user activating the function, causing the stretcher to tilt unexpectedly. See Figure 2: Main components and assembly of Stretch Leveler. Trapezoidal nut circled.
