syngo.via RT Image Suite
with syngo.via VB30, VB40, VB50 and VB60

Customer Safety Advisory Notice SY052/21/S

Subject: Potential loss of unsaved results when using syngo.via RT Image Suite

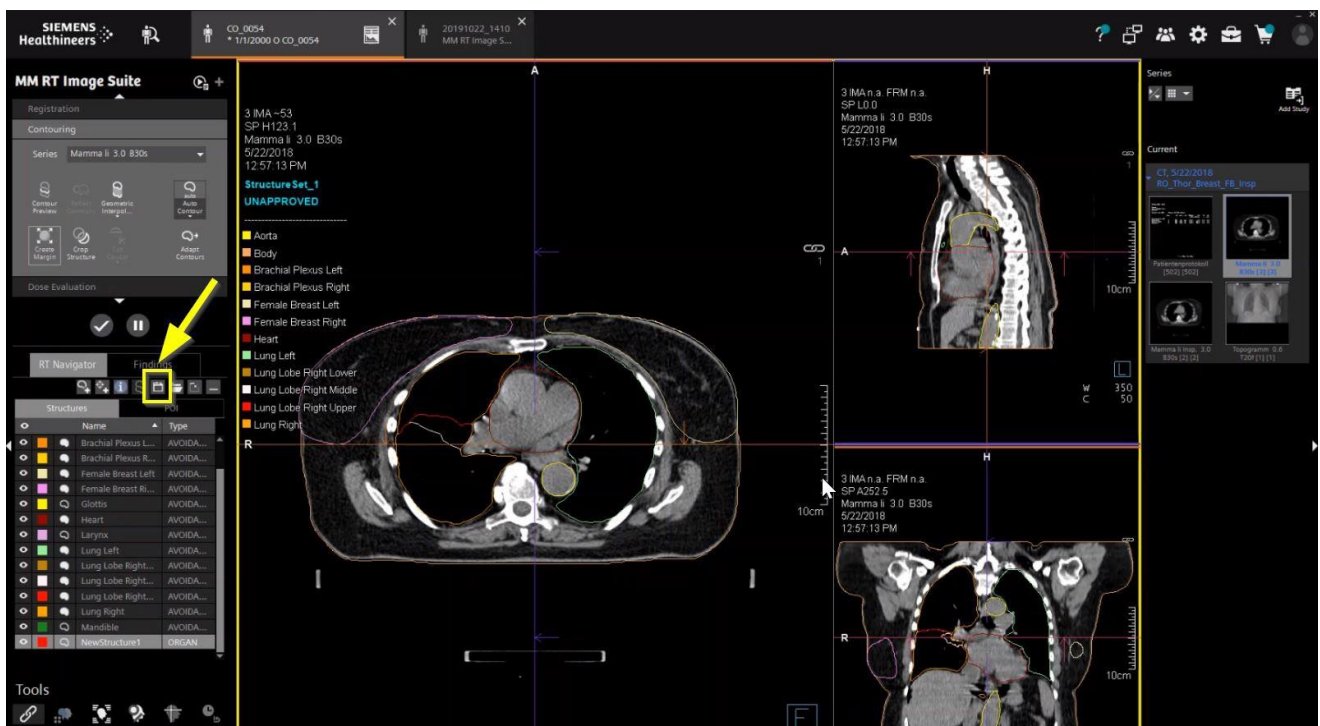
The following technical issue has been identified in a user scenario, when a structure set has already been saved in syngo.via RT Image Suite and is then saved again after further edits:
The workflow is marked as completed, but sporadically the RT structure set might not have been saved into the local database.

Figure 1: Save Structure Set from RT Navigator (screenshot taken from *syngo.via* VB60)

For *syngo.via* VB50 and *syngo.via* VB60, the following workaround is available: before clicking “complete”, save the data using the RT navigator “Save” button (see Figure 1).

Note for *syngo.via* VB50: this workaround might result in two structure sets in the patient browser. Please check the latest timestamp to identify the most recent structure set to be sent to the archive (PACS) or your treatment planning system (TPS).
