URGENT FIELD SAFETY NOTICE**bellavista™ Ventilators****Ceasing of Ventilation with Technical Failure Alarm 305
for Field Safety Corrective Action FSCA-2021-001**

17 December 2021

FSN Ref: FSCA-2021-001-FSN-1

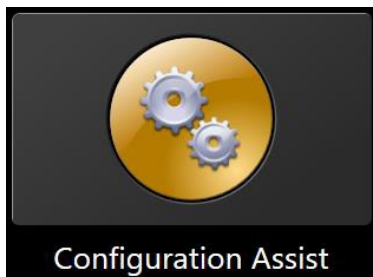
1. Open **Configuration Assist**.

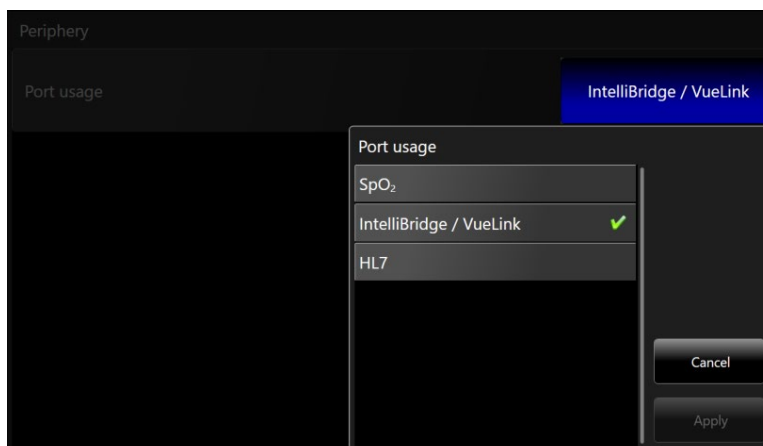
3. Ensure that **Port usage** is **NOT** configured to "HL7".

For 13.3" devices, select "IntelliBridge / VueLink" or "SpO₂".
