<b>Hillrom™</b> Hillrom Luleå Nedre Vägen 100, 975 92 Luleå, Sweden	<b>Field Safety Notice</b>	  <b>FA-2021-11-004-LUL-002</b>
---	----------------------------	--

**FSCA-identifier: FA-2021-11-004-LUL-002**

**Commercial name of the affected product,**  
Traverse Rail Carrier and Traverse Rail Carrier E-System, wide

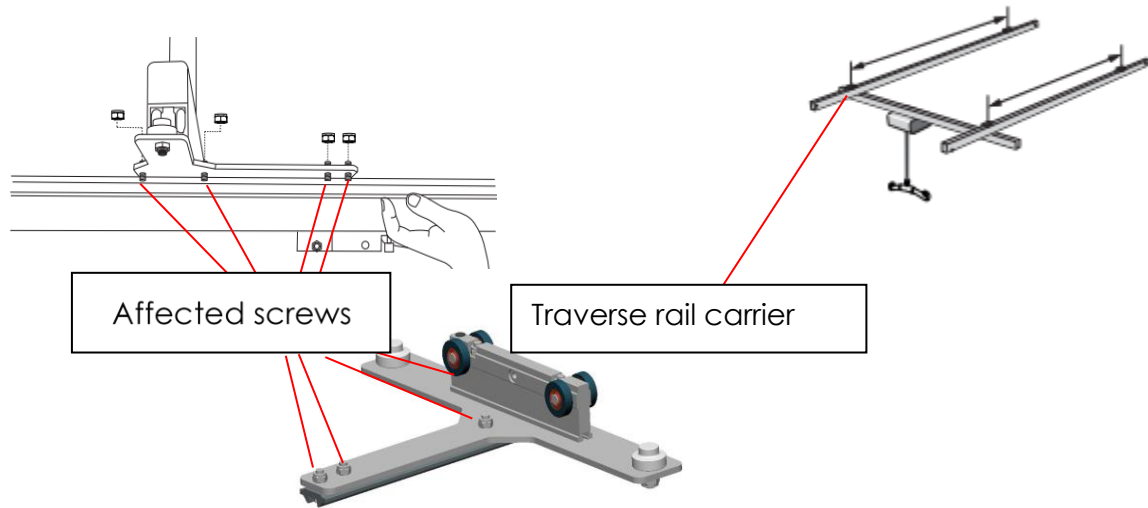
Figure 1

A traverse system consists of two primary rails with a secondary rail in-between. See figure 1 below.

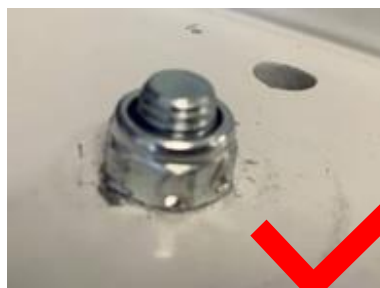
Hillrom received an out of box complaint where it was discovered that the traverse carrier had been delivered with the incorrect, non-conforming screws. The length of the screws according to specification is M8X25 (25 mm) whilst the screws of the affected batch were M8X20 (20 mm). M8X20 does not lock against the nyloc nut when installed per the installation instructions, as per figure 2 (correct screw) and figure 3 (incorrect screw) below.

Figure 2 - conforming

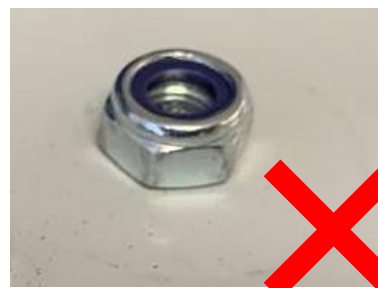
Figure 3 - non-conforming

Should the system be installed with non-conforming short screws and fail, there is potential for a patient and/or caregiver to be hit by falling objects or dropped from the lift, causing a potentially catastrophic injury.

Please identify if you have the potentially affected product in your facility (See affected device listing above). Do not use your traverse carrier until inspected by a Hillrom Technician. Return the response form below within two weeks. Upon receipt of the response form, Hillrom will contact you to schedule a visit to inspect your carriers. Should incorrect, non-conforming screws be present, these will be exchanged by an approved Hillrom technician.

Hillrom will arrange a site visit to inspect the potentially affected units. If short screws are identified, they will be exchanged with those of correct length.
