Field Notice

Hysterolux™ Fluid Management System Control Unit- REF 72205000

WOM reference no.: 2021-0002

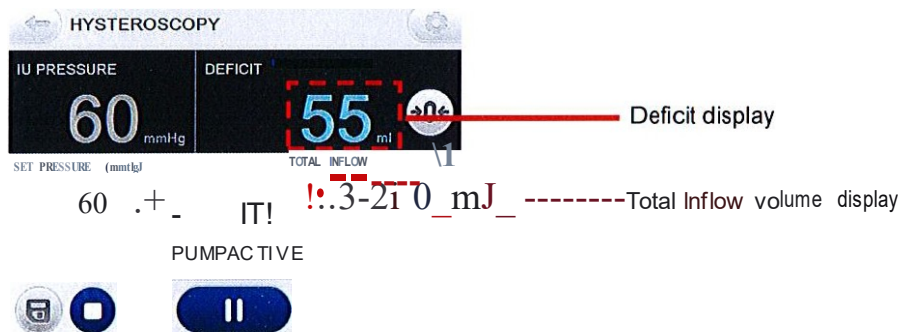
This field notification is being issued following reports from customers from the USA that the display of inflow volume on the Hysterolux™ Fluid Management System can reach its limit of 32,450 ml during long procedures. In these cases, the display does not indicate the actual inflow volume. In cases where an unusually high amount of fluid is used for distension of the patient's uterus, the calculation of the inflow and outflow volumes reaches its limit and the Control Unit display will freeze at the maximum value.

Our investigation has identified a software anomaly as the cause for this display freeze. The reason for this is that at 32,450 ml an internal software calculation threshold is being reached. As the outflow measurement will continue, the result is that the deficit accumulated up to this point will start counting backwards until 0 ml is reached.

Figure 1 Pump Control Unit display showing the calculated deficit (Deficit display) and inflow volume count (Total Inflow volume display). The latter will freeze, once 32,450 ml has been reached.

W.O.M. WORLD OF MEDICINE GmbH has developed a software version, which, when an inflow volume of 28.000 ml is reached, alerts the user that the limit is being approached and is designed to prepare the user for a manual determination of the deficit.

The new software version is implemented during the next preventive maintenance of your Hysterolux™ Fluid Management System Control Unit. If you wish to update the software of your device at an earlier date, please contact your sales representative of Medtronic Inc., who will assist in returning the unit and providing an exchange unit.
