**URGENT MEDICAL DEVICE FIELD SAFETY NOTICE**

**Medfusion™ 3500 and 4000 Syringe Infusion Pumps**

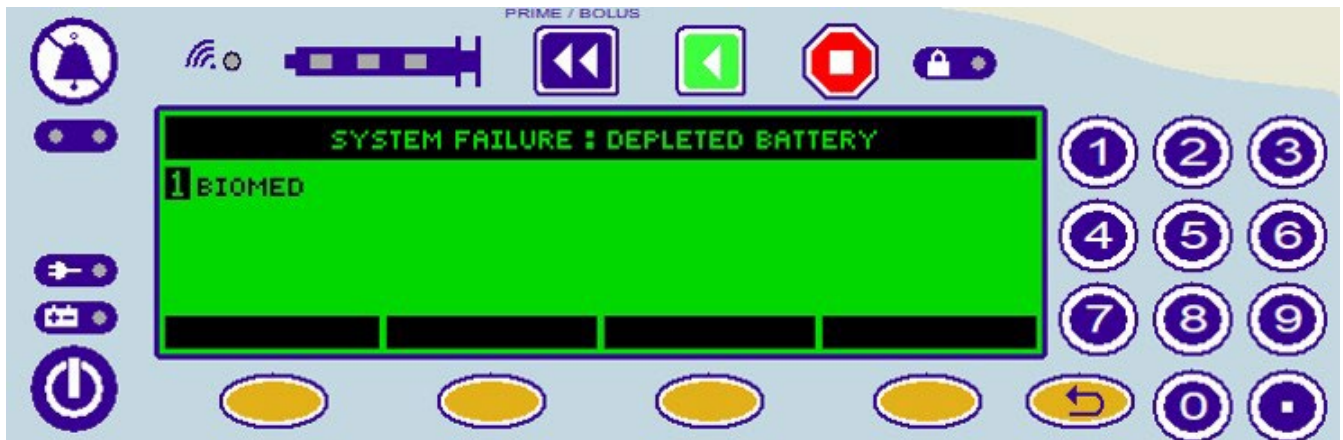
**If the pump is unplugged and running on battery, the pump assumes the battery is depleted and sounds an unexpected Depleted Battery (DB) alarm, as shown in the following figure (Figure 1), without the Primary Low Battery alarm being triggered. Even if the battery contains sufficient charge capacity, any ongoing infusion will be interrupted.**

Figure 1: System Failure: Depleted Battery Alarm

If the pump is running on battery power and a Battery Communication Timeout (BCT) alarm occurs, the pump assumes the battery is depleted and issues an unexpected Depleted Battery alarm. If the pump is infusing, interruption or delay of therapy may occur as a result. Depending on the patient's condition, the type of medication being delivered, the length of time the therapy is interrupted, and the level of clinical supervision, prolonged symptoms and a potentially life-threatening situation could occur. **To date, Smiths Medical has received reports of four serious injuries related to this issue.**

3. Unless your facility informs you that they disabled pump wireless communications, **keep the pumps plugged into AC power whenever possible.**
4. **If possible, do not use the pumps if they are disconnected from AC power.** If you must use the device on battery power, for example, when transporting a patient who has critical medications infusing, **bring backup pumps** to use in case this issue occurs. **Be aware that this issue may occur on backup pumps as well.** Plug the pumps back into AC power as soon as possible.

5. If this issue occurs while a pump is on battery power:
  - Press the Power button to turn the pump off.
  - Plug in the AC power cord, and turn the pump on. You can resume the infusion from the point when the alarm interrupted the infusion by following these steps:

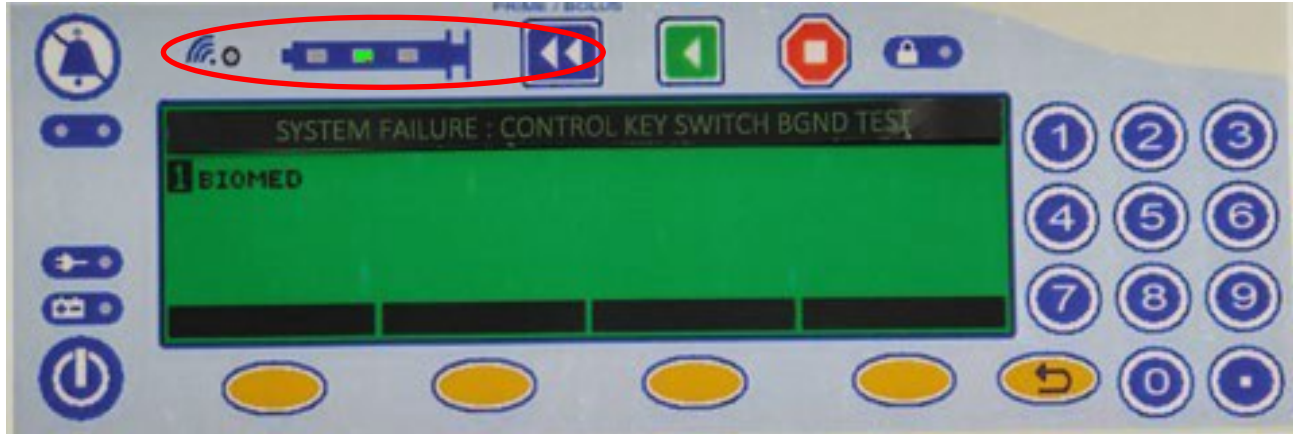
the pattern recycles. **If a System Failure alarm occurs during the small window of time when the pump is transitioning from IVOT delay to IVOT delivery, the pump may continue to run without the ability to terminate infusion via the Stop or Power keys.** In the following figure (Figure 2), the green light indicates infusion is ongoing even though the pump displays a System Failure alarm.

Figure 2: Green light indicates IVOT Infusion Continues after System Failure

Failure of the pump to stop running in a System Failure condition could result in over-delivery of medication which could cause serious harm or death. **To date, Smiths Medical has received reports of one serious injury potentially related to this issue.**

1. **Do not use the IVOT delivery mode until this issue is fixed in a future software update.** Program each infusion separately instead of using the IVOT delivery mode program.

2. If an IVOT delivery mode program is inadvertently programmed and this issue occurs:
  - Immediately remove the syringe from the pump to stop the infusion, and press the Power button to turn the pump off.

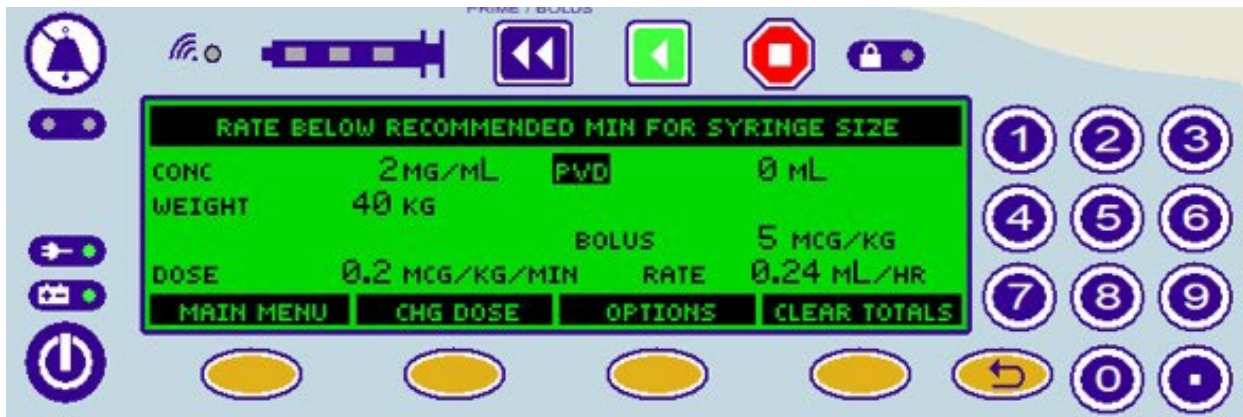
Under certain conditions, **the pump may use incorrect syringe parameters to determine if the programmed rate is below recommended minimum for the syringe size.** The pump will display a false “Rate Below Recommended Minimum for Syringe Size” alarm if this occurs, though the rate may be appropriate for the loaded syringe. The following figure (Figure 3) contains an example of this alarm screen.

When this occurs, the pump uses the Recommended Minimum Rate for the largest syringe of the same brand in the configuration for the Rate Below Recommended Minimum Rate check instead of the Recommended Minimum Rate for the syringe loaded into the pump. Although this issue does not directly impact delivery accuracy, and the pump will display the correct syringe brand and size, **this issue has the potential to affect fluid delivery since it may impact the rapid occlusion detection ability of the pump. “Pressure Increasing” alarms may occur earlier than expected or have false alarms, either with or without an occlusion present.**

Figure 3: False Rate Below Recommended Minimum for Syringe Size Alarm

The occurrence of a false “Rate Below Recommended Minimum for Syringe Size” alarm does not prevent programming or initiating an infusion but may lead to a delay in the initiation of therapy. This issue may cause “Pressure Increasing” alarms to occur earlier than expected or have false alarms, either with or without an occlusion present, which may inappropriately interrupt infusions. This may also cause therapy delays while the clinician addresses the issue and reprograms the infusion. To date, Smiths Medical has not received any reports of serious injuries or deaths related to this issue.

- If multiple syringes are needed for an infusion, program each syringe as a new infusion.**
- If you see this false “Rate Below Recommended Minimum for Syringe Size” alarm notification, do not continue the infusion: clear the infusion and re-program the infusion with the desired infusion parameters and syringe.

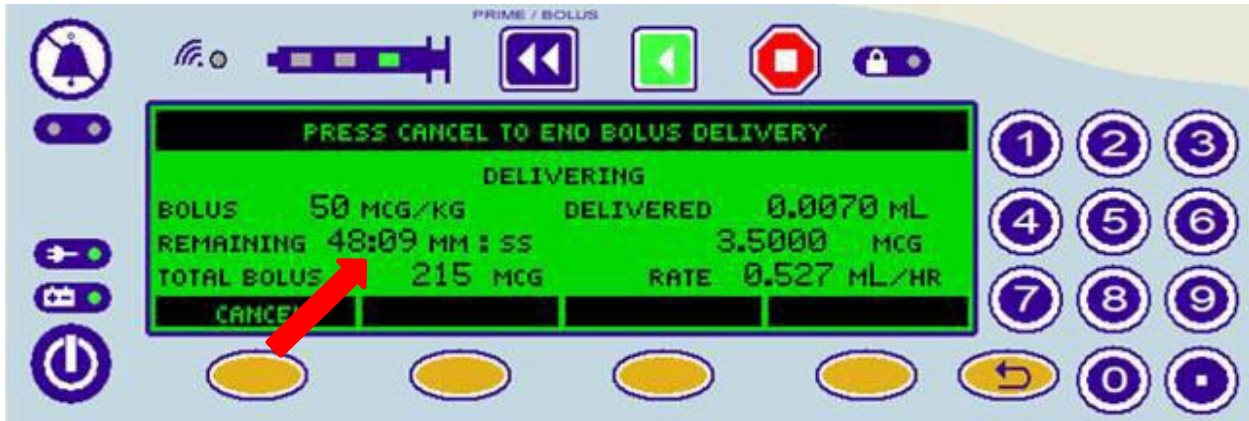
In rare situations, the pump may display an incorrect value for the time remaining during a **Bolus Dose or Loading Dose infusion** (see Figure 4). If this issue occurs, the **pump will infuse correctly to the intended infusion time even though the displayed time remaining is incorrect**. The pump appropriately transitions to continuous infusion upon completion of the Bolus Dose or Loading Dose as programmed.

Figure 4: Example of Incorrect Time Remaining. “REMAINING 48:09 MM:SS” should be displayed as “REMAINING 04:09 MM:SS”

Displaying incorrect or conflicting information to users could potentially result in the user interrupting the therapy due to confusion, which may also cause a delay in therapy. To date, Smiths Medical has not received any reports of serious injuries or deaths related to this issue.

1. When programming and monitoring Bolus Dose and Loading Dose infusions, verify that the displayed time remaining on the screen is the same as the intended time.

- **If the displayed time remaining is incorrect, your options include:**
    - Depending on the clinical scenario, including consideration of the patient condition and the medication, use your clinical judgement to determine if it is appropriate to continue the infusion with the incorrect remaining time displayed, while closely monitoring the Bolus or Loading Dose to verify that the infusion converts to the continuous infusion at the intended time.

- Program the intended Loading Dose or Bolus Dose as a separate intermittent infusion. When the infusion completes, program the continuous infusion.
