FIELD SAFETY NOTICE

APR-04-2022 | Reference 605477

Subject: 605477 - NICCI Field Action

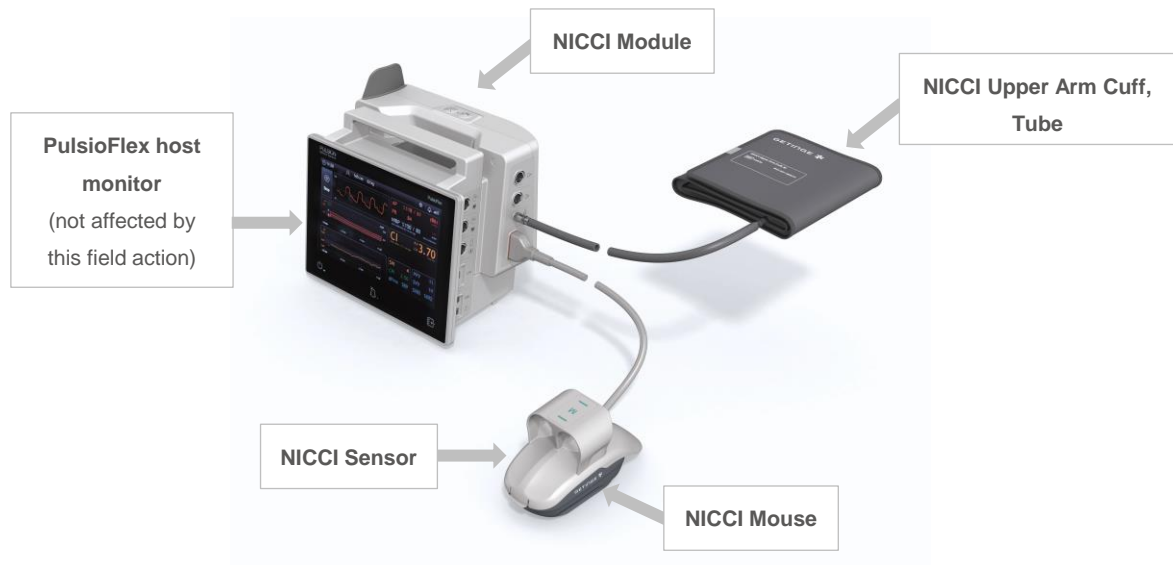
Figure 1: NICCI Technology components

The blood pressure values displayed by the NICCI Technology can deviate widely from the expected values. This value deviation has been observed

- as offset (constant positive or negative deviation from the expected values) and
- drift (continuous increase or decrease of values over time compared to the expected values).

A root cause for the offset is seen in the inherent difference between the two measurement methods (oscillometric vs. invasive). Further root cause investigation is ongoing.

- Immediately verify, if you have any of the products listed on page 1.
- Immediately separate products listed on page 1 to prohibit any further use.
- Immediately stop using the products listed on page 1 and monitor the health status of any patient who has been monitored with the NICCI Technology closely for signs of deterioration.
- Immediately contact your Getinge local representative to plan the return of the products and financial compensation of the returned goods.
- Complete and return the attached acknowledgement form and maintain awareness of this notice and related actions until the involved products have been removed to ensure effectiveness of the corrective action.
