# Urgent Medical Device Field Action

MAR-18-2022 | REF-605552 | Rev A

## Subject: VOLISTA paint chipping

Volista StandOp cupolas which has been manufactured until 31-Dec-2020.

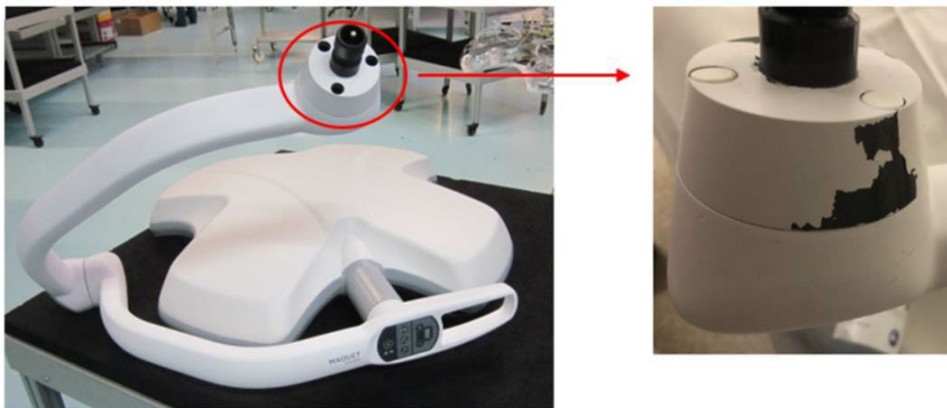
Under certain conditions, it was established that the paint could chip on a specific part of the fork. Therefore, there is a risk probability that paint particles may detached and fall in the operating field.

- The paint peeling is located on a specific part of the fork, as shown on the pictures below:

This issue may result at worst in a potential infection if particles fall during surgical operation in the patient body or in the operating field.

For remediating to this possible paint chipping, we require your contribution in paying attention to your device, and then if you experience the paint chipping on the affected part, to follow the instruction for our service support to replace the part with one with improved paint adhesion.

- Should you detect a paint peeling on this part of the fork, please evaluate if you should stop using your Volista and contact systematically your Getinge representative.

The Getinge Representative and our Service Support will proceed with the replacement in the shortest time-interval.
