URGENT FIELD SAFETY NOTICE

Tibial Components / Modular Joint Component Units of
Endo-Model - M Modular Knee Prosthesis System

Tibial Components of
Endo-Model SL Rotational and Hinge Knee Prosthesis System

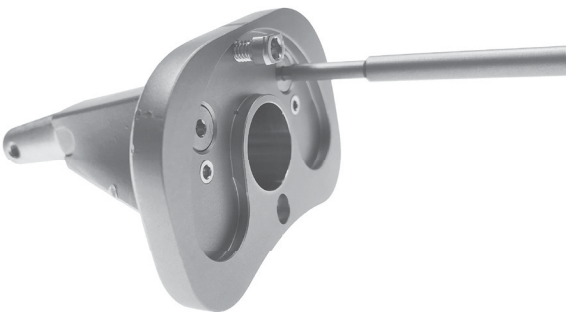
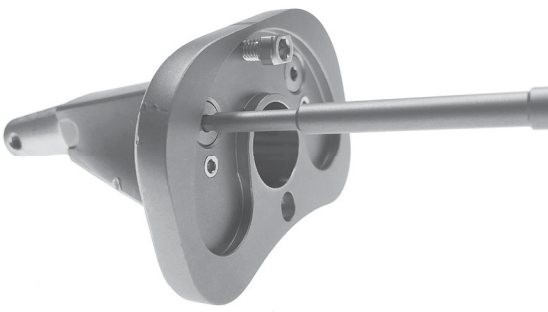
Endo-Model SL

= screw removal impossible?

If a Tilastan proximal spacer is to be used and either one or both blind screws of the modular tibial component cannot be loosened, then the following modified surgical technique is to be performed.

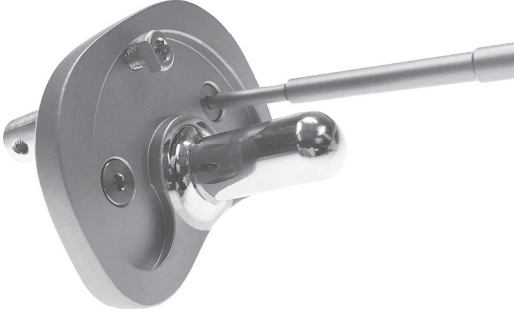
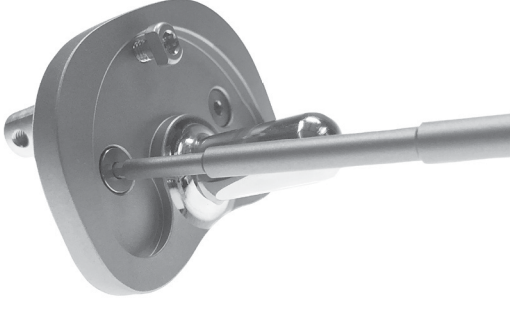
Endo-Model – M

<p style="color: red;">✘ = screw removal impossible?</p>

If a Tilastan proximal spacer is to be used and either one or both blind screws of the modular tibial component cannot be loosened, then the following modified surgical technique is to be performed.
