Update - Field Safety Notice
Philips Respironics - Hospital Respiratory Care

Philips V680 Ventilator
Software correction regarding error code 1008 - 2020-CC-HRC-004/ FCO86600058

13-May-2022

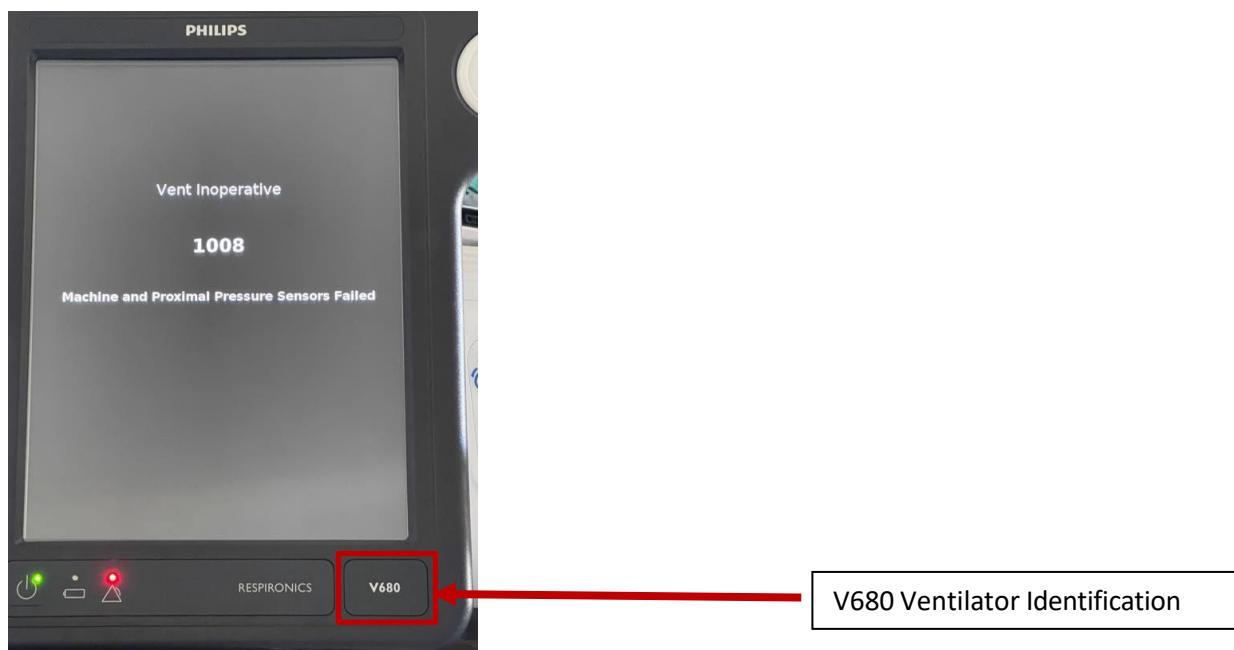
During dual-limb invasive ventilation, a patient cough of sufficient magnitude to drive circuit pressures above 95 cmH₂O for longer than 150 milliseconds may cause a "Vent Inoperative 1008: Machine and Proximal Pressure Sensors Failed" alarm (image shown below), which will cause the V680 ventilator to cease therapy and the ventilator will not function, however, it will remain powered on.

As stated above, if there is a “Vent Inoperative 1008: Machine and Proximal Pressure Sensors Failed” alarm, this will cause the V680 ventilator to cease therapy. A cessation of ventilator therapy while in use on a patient could potentially lead to severe hypoxemia and hypercarbia.

As described above, Philips will be deploying Software Version 1.40 which includes a change to prevent the 1008 error code from occurring as a result of a patient cough.

Philips will be contacting you to schedule an appointment to update your V680 device(s) software to Version 1.40.
