Urgent Field Safety Notice

Risk of Minute Ventilation artefact oversensing in patients with a subset of abnormal high polarization XFine passive pacing leads, when connected to ALIZEA / BOREA pacemakers.

FSCA identifier: CRM-SAL-2022-001

Affected devices: Subset of MicroPort CRM XFine leads (models XFine TX25D, XFine TX26D, XFine JX24D; XFine JX25D) connected to MicroPort CRM ALIZEA or BOREA pacemakers (models ALIZEA DR 1600, ALIZEA SR model 1300, BOREA DR model 1500, BOREA SR model 1200).

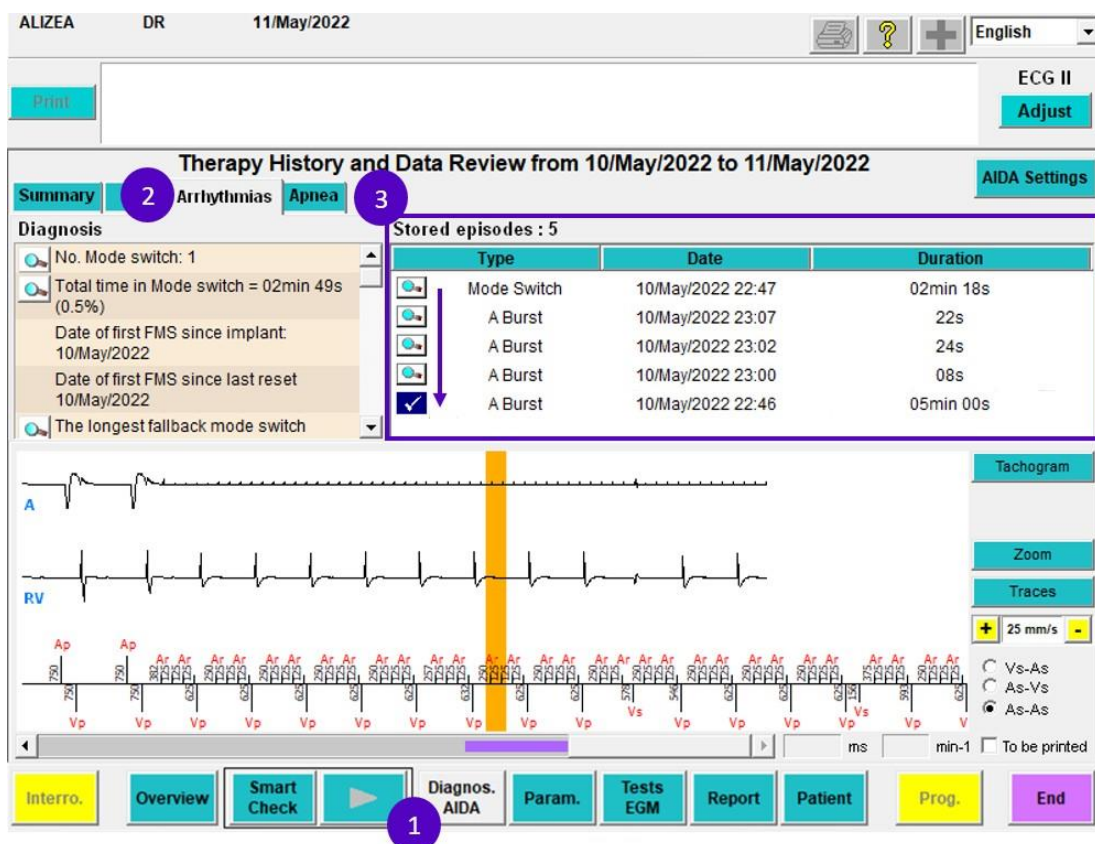
Figure 1: Sequence for checking the presence of MV oversensing in recorded episodes

1. Select the “Diagnos. AIDA” tab in the menu bar at the bottom of the screen;
2. Select the “Arrhythmias” tab;
3. Check recorded episodes individually to identify the presence of MV oversensing.

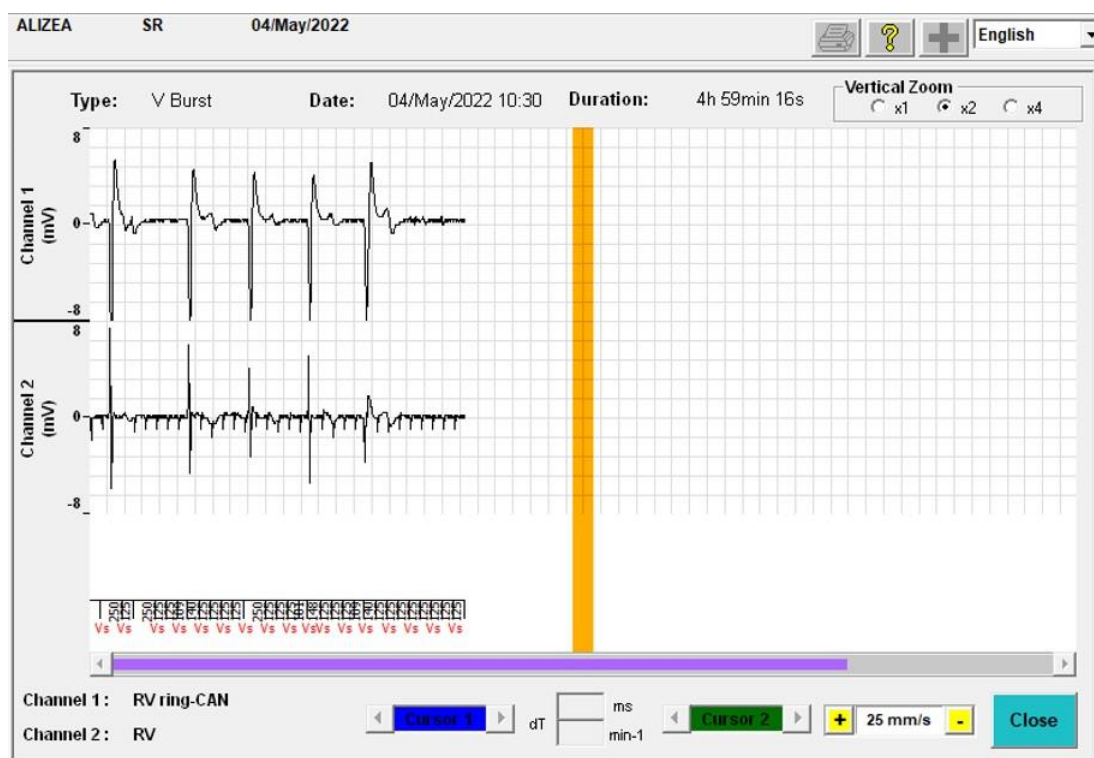
MV noise oversensing is characterized by the presence of repetitive 125ms or 250ms cycles (as illustrated below), visible in:

Figure 2: Illustration of “V Burst” episode due to MV noise oversensing on an SR pacemaker

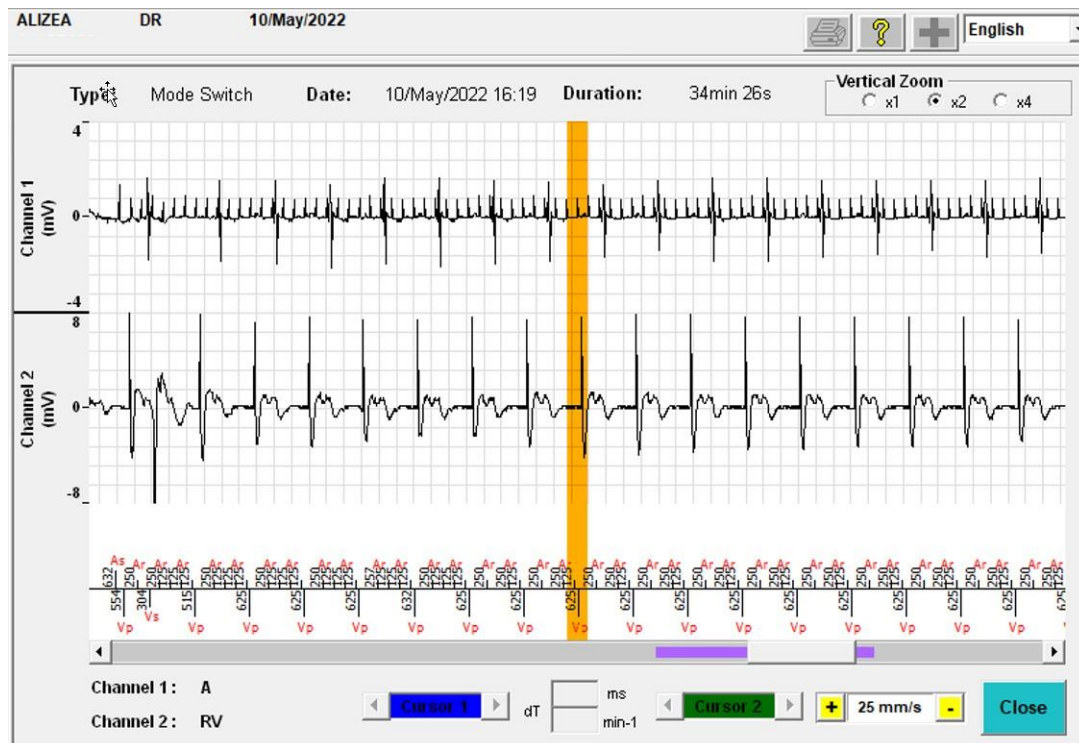
Figure 3: Illustration of “Mode Switch” episode due to MV noise oversensing on a DR pacemaker

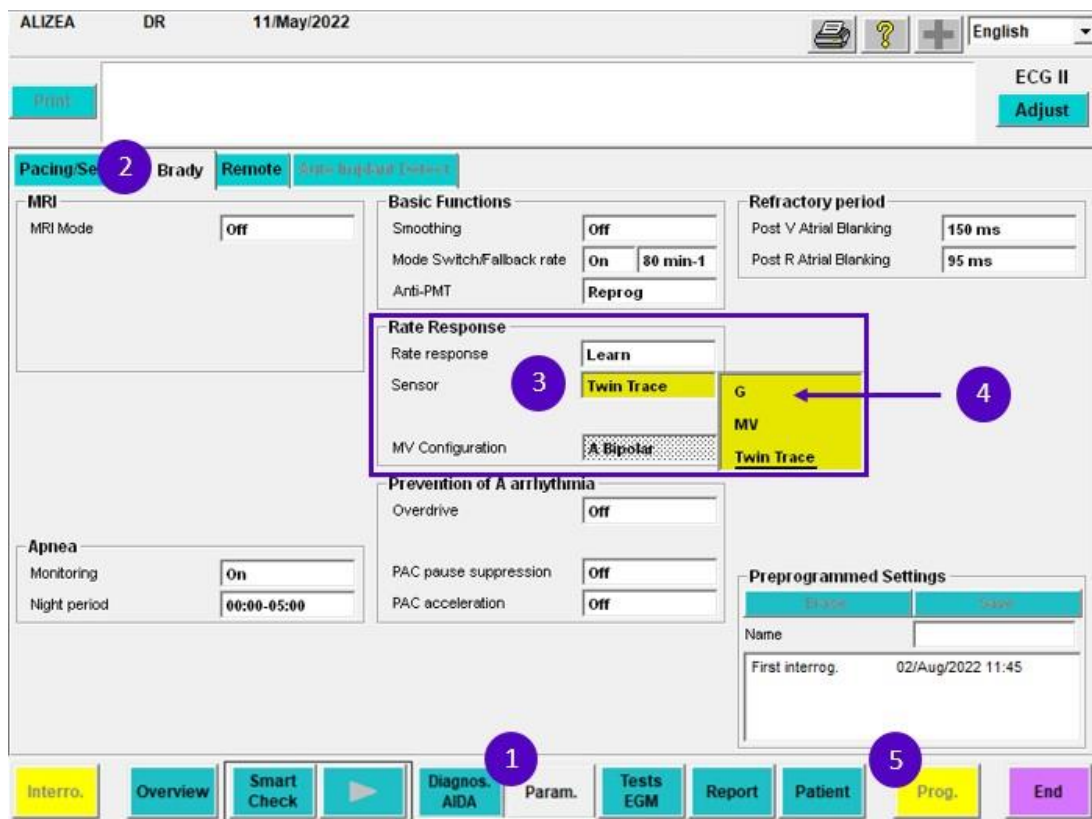
Figure 4: Sequence for disabling the MV sensor functionality

1. Select the “Param.” tab in the menu bar at the bottom of the screen;
2. Select the “Brady” tab;
3. Check the status of the “Sensor” parameter in the “Rate response” zone;
4. Deactivate the “MV Sensor” parameter by selecting “G” and then press “Prog”. The parameter value will be then changed to G only.
