URGENT - Field Safety Notice

Liver Assist Perfusion Set

Quality defect – potential leakage of set

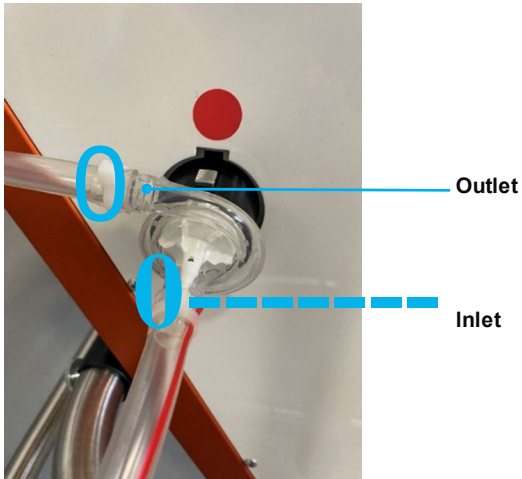
Figure 1: connections of the pump head

In rare cases, leakage could occur at the tubing connections of the pump head. Each perfusion set contains two pump heads with both an inlet and an outlet. The potential leakage can be determined already during priming when high pressures are applied. The leakage can be noticed by drop formation or persistent air bubbles at the tubing connections of the pump head

We are currently investigating the root cause for this defect. XVIVO have not received any reports of serious injuries or death due to the issue.

1. During priming, carefully check the connections at each pump head (4 in total). Check the inlet side for potential air bubbles in the solution or leakage. Also check the outlet side for potential leakage of solution. When handling the pump head do not extensively pull the tubing or connections.
2. If above issues are observed during priming, you can choose to replace the cable tie of the affected pump head or replace the full set.
3. If replacing the full set, save the affected set as it needs to be returned for investigation and refund.
4. If no leakages or persistent air bubbles are observed the perfusion set can be used as intended.

For an experienced user, the affected connection at the pump head can be improved by replacing the cable tie. This should take place before placing an organ on the device. Take notice that the recommended size of the new cable tie is smaller (3,5 mm instead of the current 4,6 mm).
