## Urgent Field Safety Notice

**Commercial name of the affected product:** Accelerator a3600

**FSCA-identifier:** FSCA -ACP - 202303 - 02

**FSN-identifier:** FSN -ACP - 202303 - 02 v.2

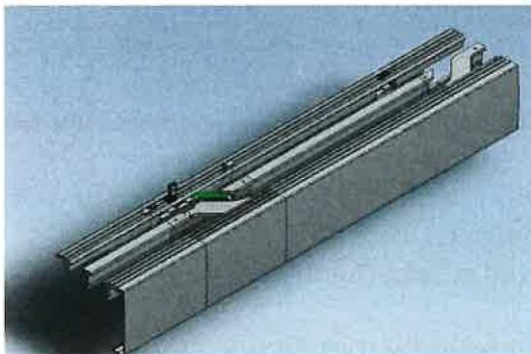
*Image 7: Divert gate position*

The scenario occurs in the case of a divert malfunction.

To avoid the occurrence of the described issue Inpeco recommends to visually check every day the gates at the buffer lane entry of the impacted modules (refer to Image 7) to verify that:
