## Urgent Field Safety Notice

**Commercial name of the affected product:** Aptio Automation

**FSCA-identifier:** FSCA - AP2 - 202303 - 03

**FSN-identifier:** FSN - AP2 - 202303 - 03 v.2

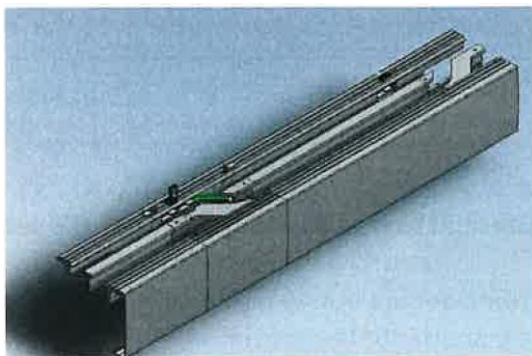
*Image 7: Divert gate position*

To avoid the occurrence of the described issue Inpeco recommends to visually check every day the gates at the buffer lane entry of the impacted modules (refer to Image 7) to verify that:

If the visual check is not passed, contact your local technical support for assistance before using the Automation System impacted modules to process samples.

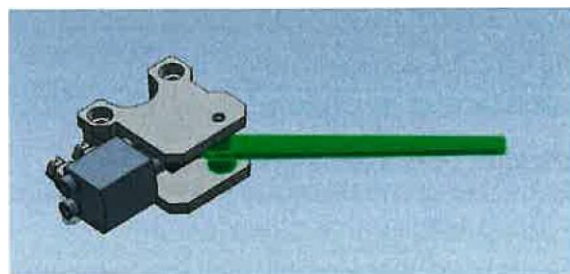
*Image 2: Divert appearance*

- there are no obstructions that prevent the correct activation and movement of the divert;
- the divert looks to be intact, refer to Image 2;
- the position of the divert is aligned to the profiles when it is diverting a tube, refer to Image 3; tubes that need to be routed by the module are diverted fluidly, without any missing or partial block of the carrier.
