## Urgent Field Safety Notice

**Commercial name of the affected product:** Flexlab

**FSCA-identifier:** FSCA - FLX - 202303 - 07

**FSN-identifier:** FSN - FLX - 202303 - 07 v.2

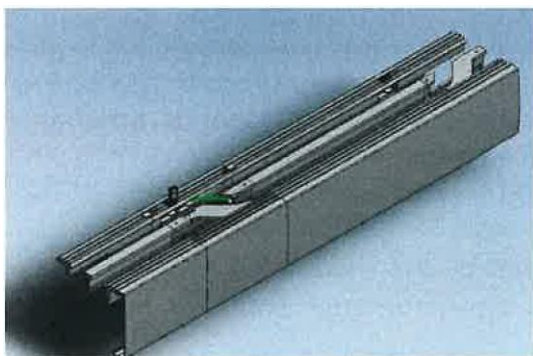
*Image 7.a: Divert gate position*

The firmware of the modules listed above has the potential to mis-associate sample IDs leading to incorrect results or delayed results.

Only in this specific scenario, the Tube A may be released by the module as Tube B due to a miscommunication between the module firmware and the Automation software without any error message.

To avoid the occurrence of the described issue Inpeco recommends to visually check every day the gates at the buffer lane entry of the impacted modules (refer to Image 1.a and Image 1.b) to verify that:
