UFSK\_FSN\_500 XLE\_head-side lowering lying  
surface\_SN2000-4506\_230427\_en.docx

27.04.2023

## Safety notice

### Restricted use for Treatment chairs 500 XLE with serial numbers 2000-4506

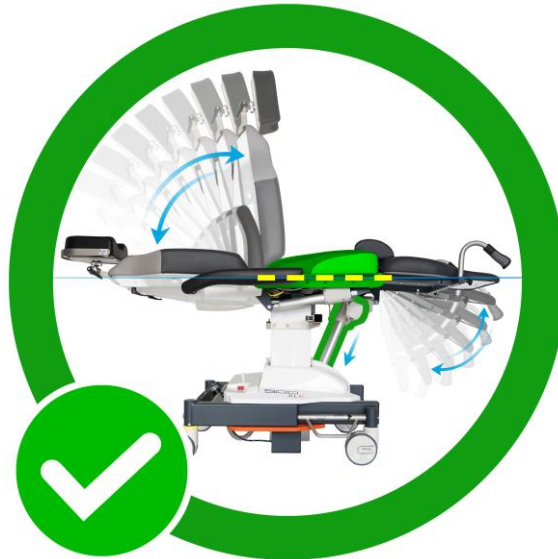
## Safe patient positions of 500 XLE (SN 2000 - 4506)

**ATTENTION!** The seat part must be in a horizontal position to the floor (see green cushion), the seat part drive remains in the retracted position (green marked component). Adjustment movements, e.g. into the reset position, are still possible (see adjustment positions of back and leg part shown in grey).

**The seat part drive is retracted so far with the patient in position that the seat part is in a horizontal position; the seat part may no longer be adjusted with the positioned patient (see attachment: Illustration of safe and critical patient positions).**

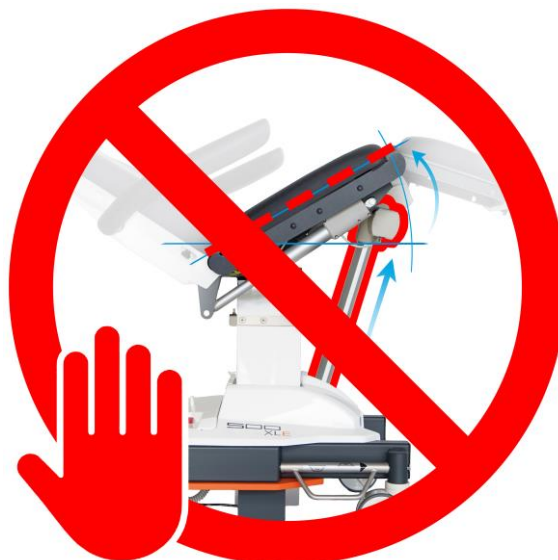
## PROHIBITED - Critical patient positions!

**PROHIBITED!** Tilting of the seat part by extending the seat part drive is prohibited. Memory positions that have been saved must be adjusted

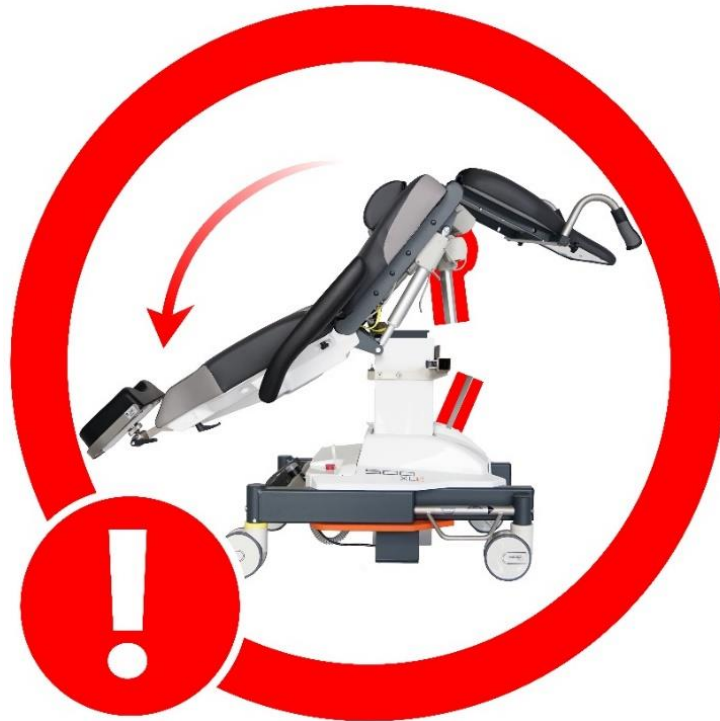
## ATTENTION - WORST CASE!

A worsened self-locking of the seat drive can lead to overriding the end position of the seat drive when positioning the patient with the seat part in an inclined position. This can result in a possibly sudden head-side lowering of the lying surface (see attachment).

If the safe patient positions are not observed - in "worst case scenario" - this will cause the separation of the seat drive.

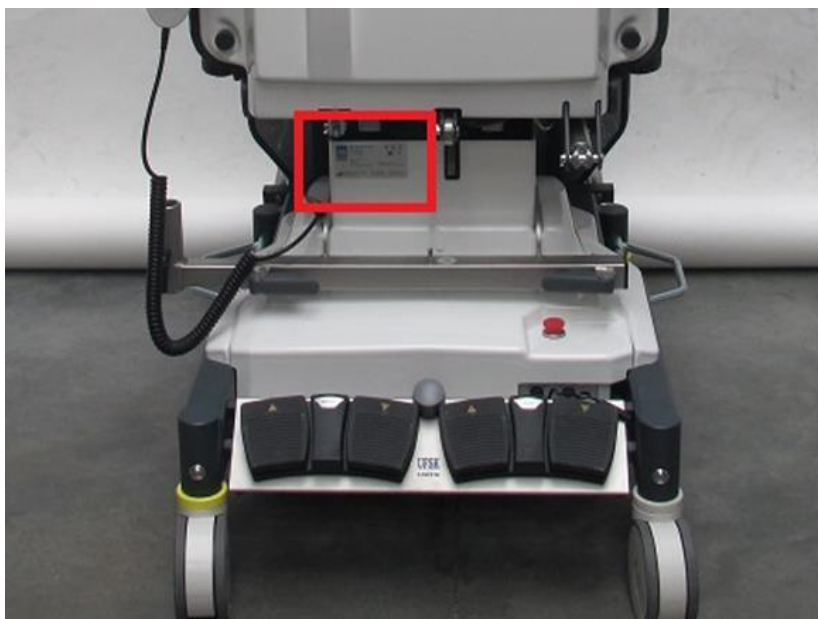
## Where is the nameplate with the serial number (SN)?

Here you can find the nameplate of Treatment chair 500 XLE.  
Identify the SN number! **Only SN-range of SN 2000 - 4506 is affected!**
