To our customers of the
Emergency and Transport Ventilator
Oxylog 3000 *plus*

Important Safety Notice

Oxylog 3000 *plus* may not switch to mains supply following battery operation.

All Oxylog 3000 *plus* devices Part No 5704811 and 5704813,
Basic UDI DI 040486751304015FK19Z000XW, may be affected.

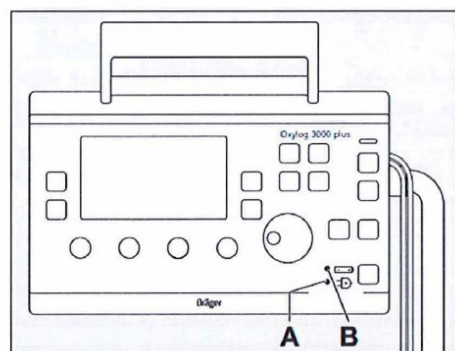
The root cause of the inability to switch to mains supply could be identified as a problem of the charging circuit which can occur in the following sequence of situations:

1. a prior battery issue indicated by the alarm "**No int. battery charging**" occurred during use on mains supply - see below

2. the internal battery is NOT removed and reinserted or replaced as recommended as remedy for this alarm message according to the Instructions For Use (IFU) and
3. the device is disconnected from mains supply (e.g., for patient transport) and
4. the device is reconnected to mains supply.

Only if all the conditions are fulfilled and after the aforementioned alarms were given, ventilation could stop as soon as the battery charge was depleted.

Prior to a device being used on a battery supply, ensure the correct switchover by disconnecting from and reconnecting the device to a mains supply. Please verify the colors of indicators **A** and **B** as per the diagram below:

Please make sure that the battery is always removed and reinserted or replaced after occurrence of the **"No int. battery charging"** alarm message, without removing the device from mains supply.

A should display a green light, and **B** should display a green or yellow light. If **B** displays a red light, you should disconnect and reconnect or replace the battery.

Your local Dräger Service representative or our service partner will contact you to arrange a date for a firmware update of the Printed Board Assembly Charger to be performed free of charge.
