URGENT FIELD SAFETY NOTICE

Subject: 812435 - Replacement of Rotaflow II drive closing cover

Affected Product: 701074622 Rotaflow II drive (flex)
701074623 Rotaflow II drive (compact)

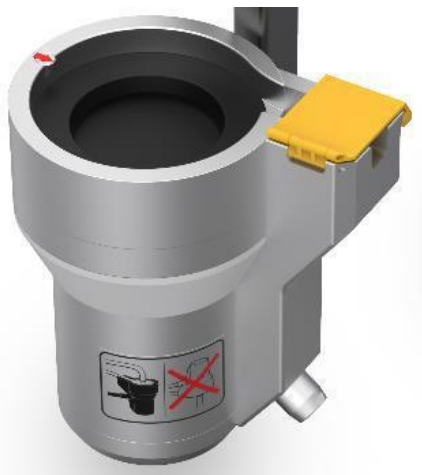
Figure 1: Rotaflow II Drive

The technical function of the Rotaflow II Drive (Fig. 1) is to drive disposable ROTAFLOW centrifugal pump (RF-32 disposable) within an extracorporeal circulation. This RF32-disposable is retained inside the Rotaflow II Drive by a locking mechanism (yellow locking mechanism, shown in Figure 1).

In October 2022 Maquet Cardiopulmonary received a complaint on issues connected to the yellow locking mechanism unlocking on patient transfer and requiring a low force to unlock.

An internal investigation identified that material behavior (strain, rigidity, etc.) is subject to change over time and a reduction of unlocking force over multiple use cycles occurs.

The noticed error can potentially cause an accidental release of the RF-32 disposable, falling out of the drive and causing pause or end of treatment.

- Action to be taken by manufacturer:**
- replacement of yellow locking mechanism with the black Rotaflow I locking mechanism by Getinge representatives (the black locking mechanism is equivalent to the Rotaflow I Drive locking mechanism)

- 1.) replacement of yellow locking mechanism with the black Rotaflow I locking mechanism by Getinge representatives (the black locking mechanism is equivalent to the Rotaflow I Drive locking mechanism)
