URGENT Field Safety Notice

Allura Xper, Allura Centron, and Azurion systems
Potential loss of imaging functionality resulting from no or intermittent X-ray radiation initiation through the wired foot switch.

15-August-2023

Reference: 2023-IGT-BST-004: Allura Xper, Allura Centron, and Azurion Systems.

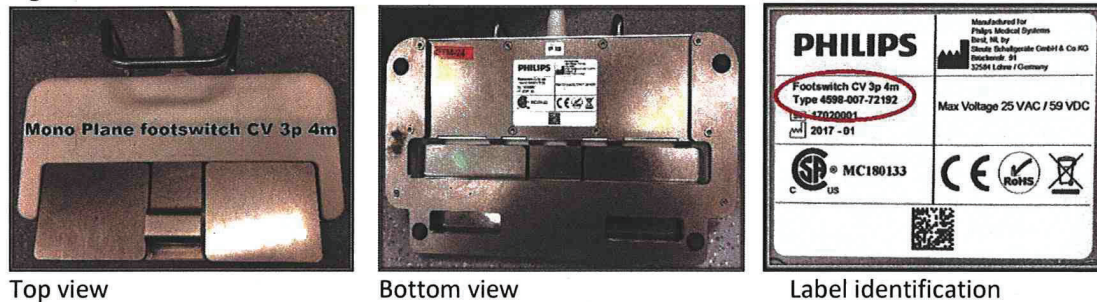
The reference/type of the wired foot switch can be found on the label located on the bottom of the wired foot switch, as shown in Figure 1.

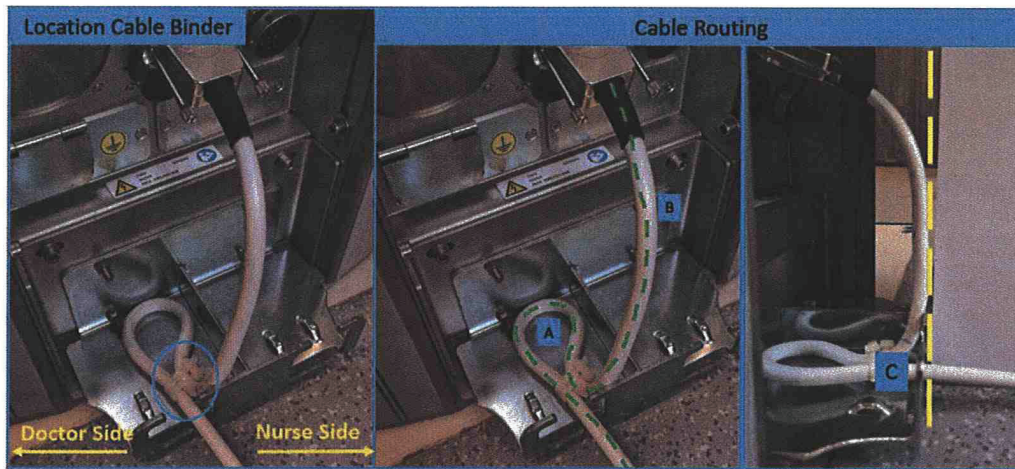
Figure 1: AD7XT and AD7XNT Patient Table

Number of cable binder(s): 2 (two)

If strain relief or routing is not correct, repair according to the repair instructions.

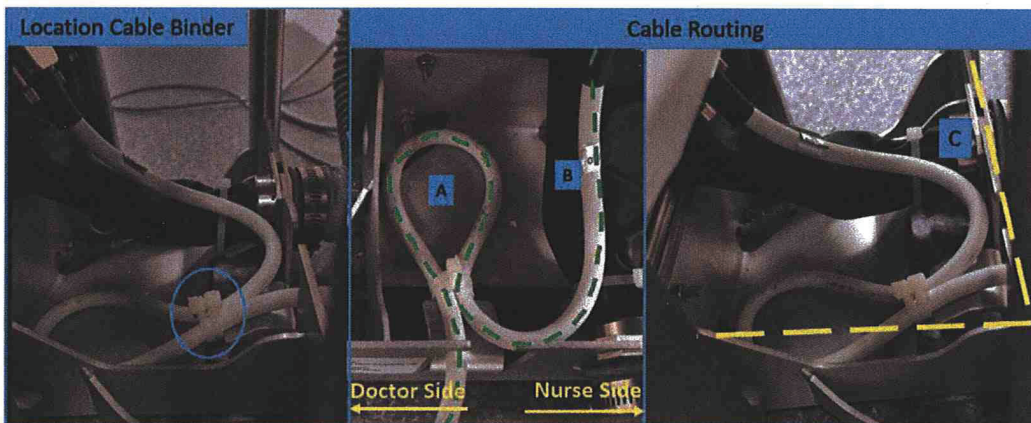
Figure 2: AD7XT and AD7XNT Auxiliary OP Rail Patient Table Strain Relief

Number of cable binder(s): 2 (two)

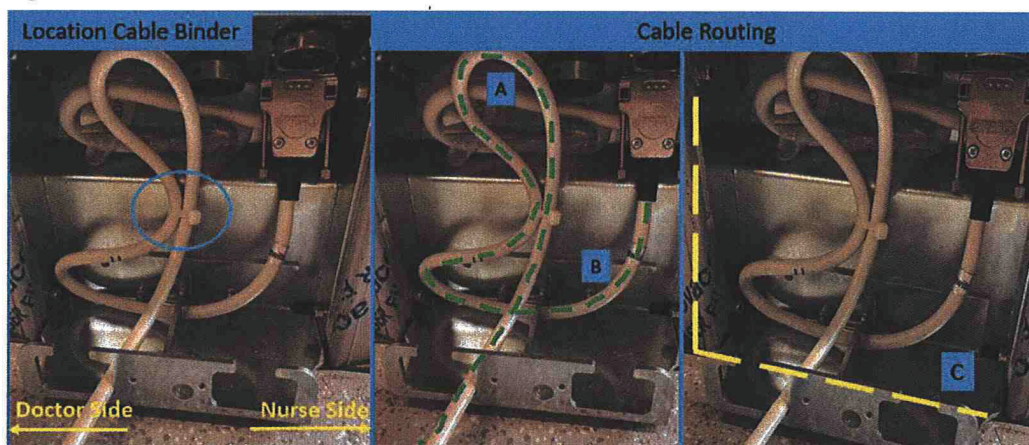
Figure 3: AD7 Patient Table

Number of cable binder(s): 1 (one)

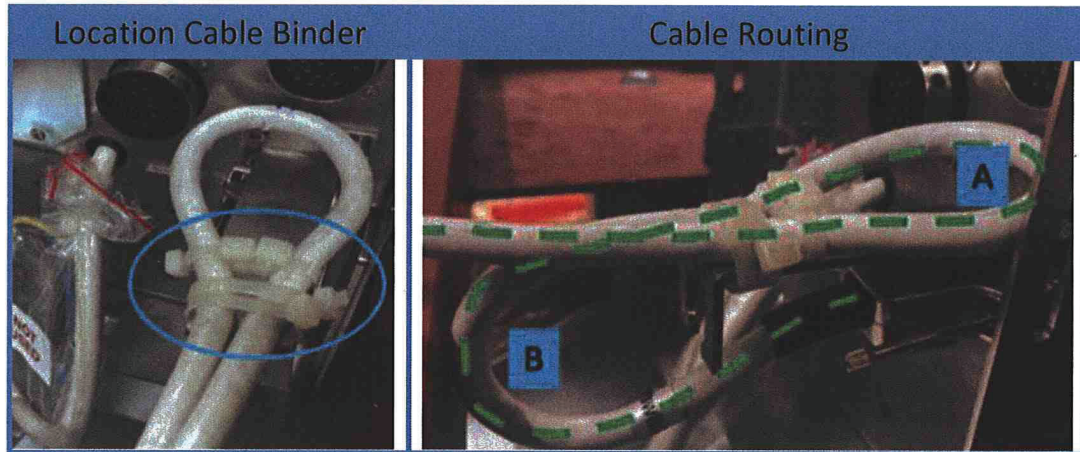
Figure 4b: AD7NT Patient Table with cable tie strain relief

Number of cable binder(s): 5 (five)

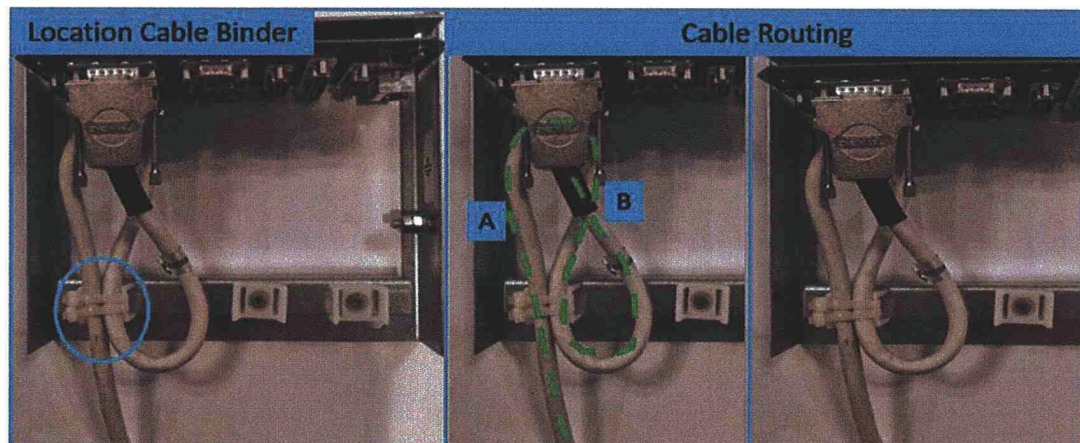
Figure 5: Pedestal Wall Connection Box

Number of cable binder(s): 2 (two)

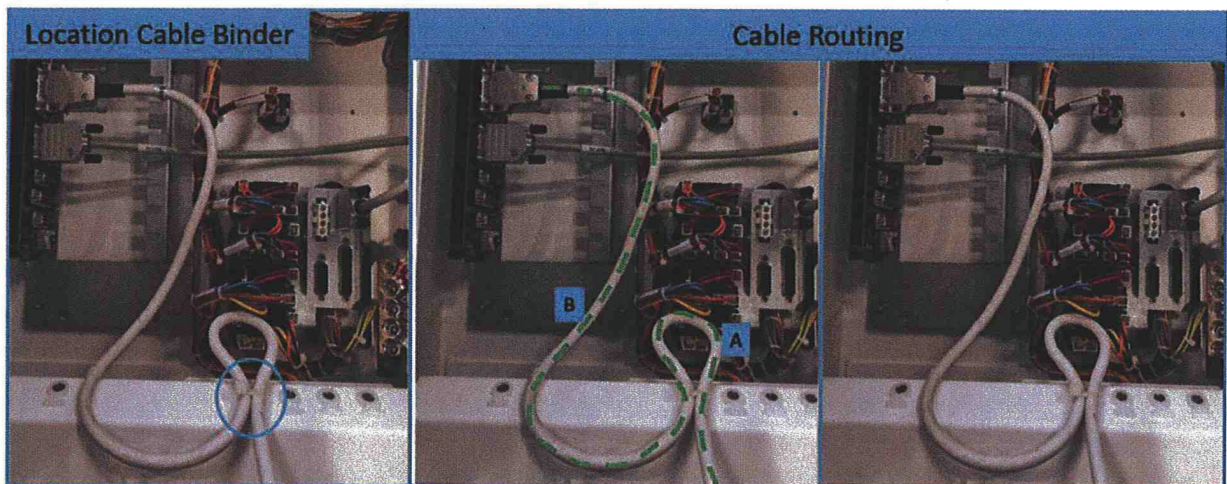
Figure 6: Surgery Wall Connection Box

Number of cable binder(s): 1 (one)

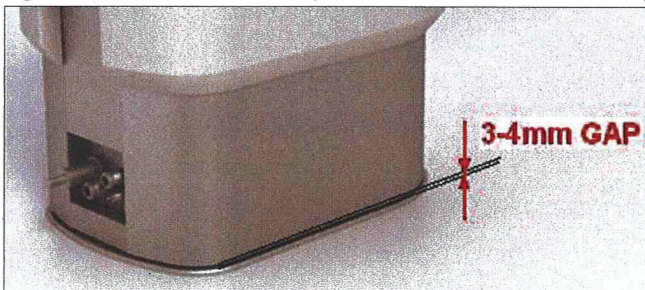
Figure 7: Non-swivel table (AD7NT, AD7XT and AD7XNT)

- For a non-swivel table
 - Make sure that the clearance to the fluid protection plate is 3-4 mm
 - Refer to Figure 7
- For a swivel table
 - Make sure that the clearance to the swivel cover is 3-4 mm
 - Refer to Figure 8

If the gap between the plinth covers and the floor does not satisfy the above requirement, adjust the plinth cover according to the repair instructions.
