**URGENT Field Safety Notice**

**BrightView, BrightView X, BrightView XCT**  
Patient Extremity Entrapment Hazard while using Pre-Programmed Motion

November 28, 2023

**Reference:** 2023-PD-CTAMI-011 BrightView Detector Collision (FCO88200537)

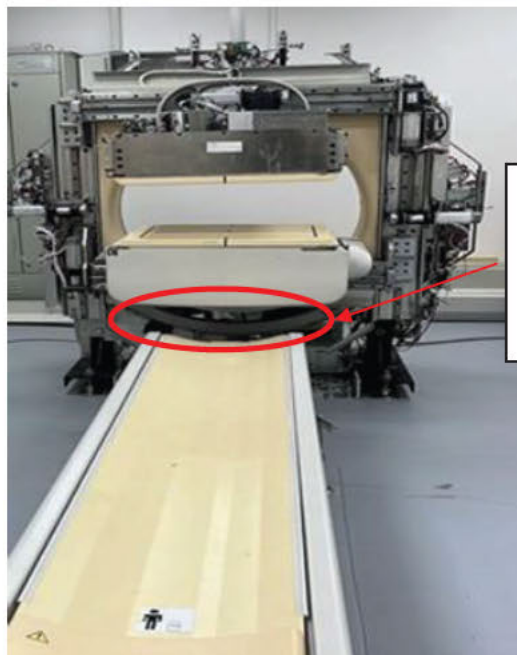
*Figure 1. Image of gap between the patient support and detector*

While using Pre-Programmed Motion (PPM) during an extrinsic quality assurance scan, a gap is created between the patient support and the detector. This gap presents a potential extremity entrapment hazard for patients while the system detectors and patient support are in motion.

Gap between the detector and patient support. During PPM, the gap may decrease creating the potential for extremity entrapment.

Philips has received one (1) report of an adverse event associated with this issue. In this reported event, the operator positioned a patient on the patient support and initiated the total body Pre-Programmed Motion (PPM). While the patient support and detectors were in motion, the patient straightened their leg due to a cramp, causing their foot to extend and become entrapped between the patient support and the detector. The patient sustained a foot fracture.

- **Monitor the patient during system movement when the Pre-Programmed Motion is in use and review the warning and caution guidance information below, as outlined in *Section 2: Safety and Regulatory Agency Compliance in the Instructions for Use*:**

- If the patient extends beyond the end of the imaging table, reposition the patient before starting any preprogrammed motion.
  - Vigilantly watch the patient to make sure that equipment or patient motion does not result in patient harm or equipment damage.

- If you perform a PPM with the patient on the imaging table, monitor the equipment motion closely to avoid contact with the patient object.
  - If any part of the system looks as if it is going to collide with the patient, use an emergency stop button to immediately stop system motion.

Philips will contact you to schedule a time for a Philips Field Service Engineer (FSE) to visit your site and install a technical solution to resolve this issue (refer to FCO88200537).
