URGENT Field Safety Notice

Philips **Azurion System** R1.0, R1.1, R1.2, R2.0, R2.1, and R2.2
Potential loss of imaging functionality and clinical data stored in the system

08-DEC-2023

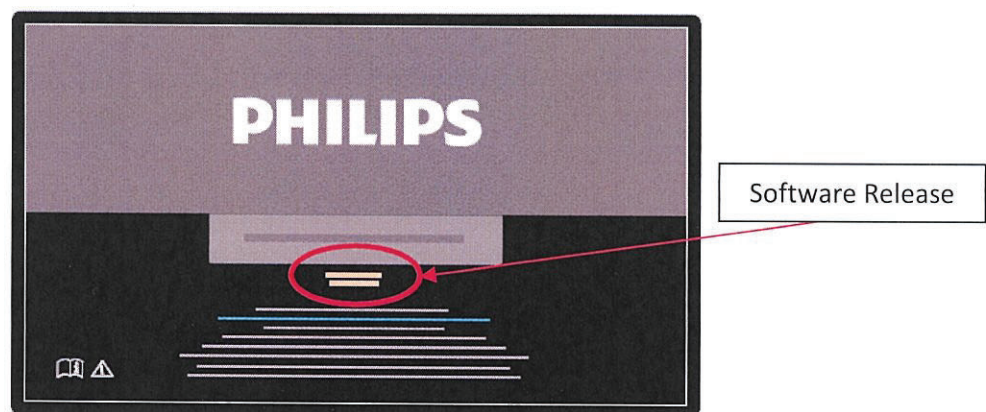
Figure 2: System start-up screen

The software version of the Philips Azurion system can be identified during start-up (Figure2).

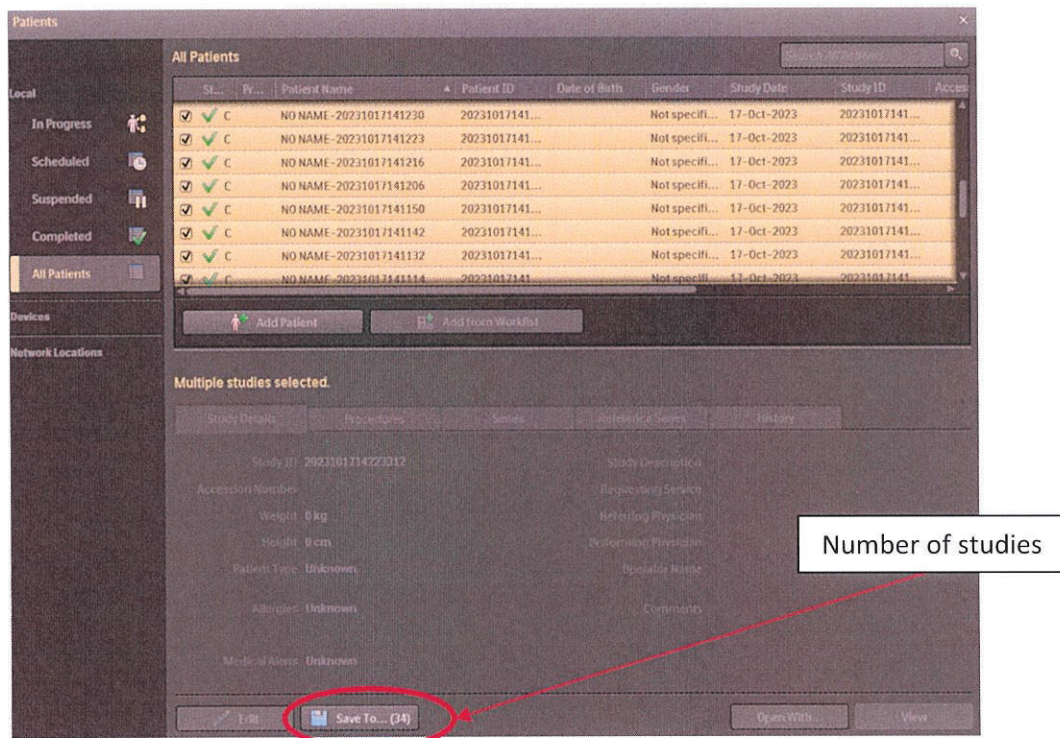
Philips has identified a potential issue which can cause the system to continuously restart (restart loop). This is likely to occur when the patient database gets too big over time (>500 studies). If this issue occurs, a potential for data loss may be expected.

The number of studies can be determined by selecting all studies in the table (Ctrl+A). The number of studies is displayed at the lower part of the screen, see image below.

Note: There is no direct relation to the image disk space used. The number of studies can be high while the image disk is only partially filled, in case only a few images are saved for each patient.

- Keep this Urgent Field Safety Notice letter with the documentation of the system until Philips corrects your system. Ensure the letter is in a place likely to be seen/viewed.
- Keep the number of studies in the patient database as low as possible, but at least below 500.

- When deleting studies, ensure the studies are archived and delete the studies in small batches (<10).
- Circulate this notice to all users of the system so that they are aware of the issue.
- Return the attached response form (page 5) to Philips promptly and no later than 30 days from receipt to confirm that the users of the system have reviewed and understood this Field Safety Notice and required actions to be taken.
