Field Safety Notice, Medical Device Correction #133261

RayStation RayPlan 7-2024A including some service packs

28th March, 2024

RSL-P-RS FSN Class III 133261

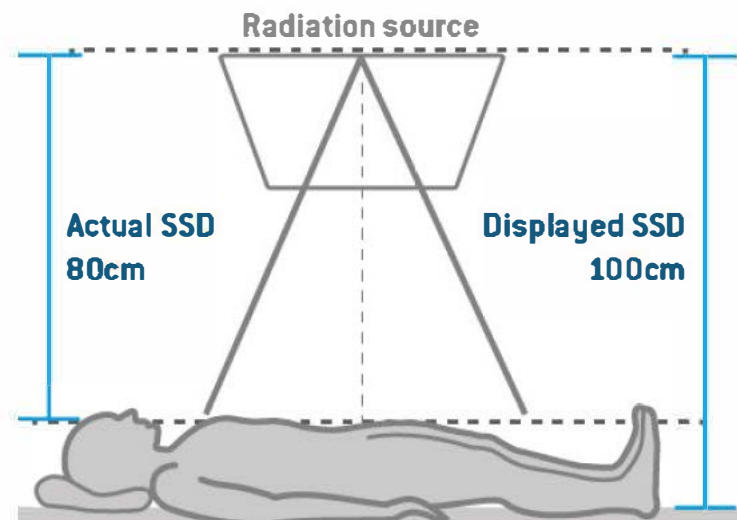
In very rare cases, the calculation algorithm for the reported SSD (i.e., the SSD displayed and exported) will miss the first ROI in the beam path and instead calculate the distance to the entry point of an ROI that lies further down in the beam path, resulting in an incorrectly reported SSD. If this occurs, the reported SSD will be incorrect in the GUI, in the plan report, in DICOM export and when accessed via scripting. Both treatment beams and setup beams may be affected. It is unlikely that all beams in a beam set are affected, since the issue will only be triggered under special circumstances of ROI geometry and beam angles. The SSD saved to a beam commissioning field to be used with arbitrary photon fields in RayPhysics can also be affected.

The reported SSD should in this example be the distance from the radiation source to the beam entry point of the External ROI. If the bug occurs, the External ROI is not included in the calculation and the incorrect reported SSD is the distance from the radiation source to the beam entry point of the couch ROI which is the next ROI in the beam path.

- The intended SSD is 100 cm and the user enters 100 cm SSD.
- If the bug is triggered, the reported SSD will be 100 cm but it will be calculated as the distance to the couch ROI. In this example, it will be displayed as 100 cm in the beam list, but the plan isocenter is in reality placed so that the actual SSD (which is the distance to the entry point of the External ROI) is shorter than 100 cm, see Figure 1 below. In this example, the actual SSD in the plan is 80 cm. All displayed values are correct, except for the reported SSD value in the beam list.
- Dose is calculated based on the plan with SSD 80 cm.
- The reported SSD in the exported RT Plan/RT Ion Plan and the plan report is 100 cm.
- If the patient is treated at SSD 100 cm, the delivered dose will not match the dose that was calculated in RayStation/RayPlan.

Figure 1. The patient shown in relation to the radiation source. In this example, the reported SSD displayed in RayStation/RayPlan is 100 cm, whereas the actual SSD in the plan is 80 cm.

- If the reported SSD is to be used for patient setup or other critical tasks, use the Measure tool to measure the distance in the patient view to make sure that the reported SSD value is correct.
- If the reported SSD value is found to be incorrect, small changes to isocenter, beam angles or the affected ROI's geometry can be made until the correct value is achieved.
- Educate planning staff and all users about this workaround.
- Inspect your product and identify all installed units with the above software version number(s).
- **Confirm you have read and understood this notice by replying to the notification email.**

This issue will be resolved in the next version of RayStation/RayPlan, scheduled for market release in April 2024 (subject to market clearance in some markets). If customers wish to continue using versions of RayStation/RayPlan affected by this notice, all users must maintain awareness of this notice. Alternatively, customers can choose to upgrade to the new version once it becomes available for clinical use.
