URGENT Field Safety Notice

Allura Xper, Allura Centron, and Azurion Systems: PC Issues
 Potential Loss of System Functionality which May Result in Delay or Termination of Procedure

28-December-2023

Reference: 2023-IGT-BST-027: Allura Xper, Allura Centron, and Azurion Systems: PC Issues Potential Loss of System Functionality which May Result in Delay or Termination of Procedure

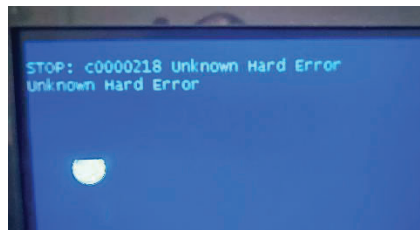
1. Switch to a different viewport on the FlexVision monitor. Upon switching viewports on the FlexVision monitor, FlexVision shows no image, a distorted image, a frozen image, or you are unable to switch between viewports (i.e., warning/error message displays “*Switching not possible. Call Service*”); or
2. System displays a Windows “blue screen” (see example below), regardless of what specific message is provided on the screen.

Example of Windows “blue screen”

Do not use the system and contact your local Philips representative immediately.
