**URGENT Field Safety Notice**

Zenition 50 and Zenition 70 systems  
Potential Loss of X-ray Imaging Functionality and C-arm Height Movement

25-Sep-2024

Reference: 2024-IGT-PUN-001

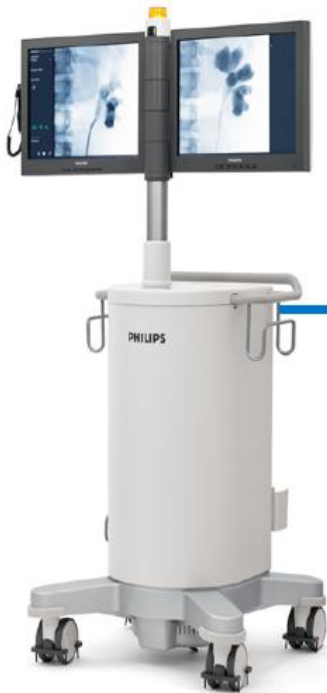
**\*Fig-1 Mobile Viewing Station (System Identification Label location)**

The system product name and model number are found on the system identification label (Fig-2). This label is on the rear side of the Mobile Viewing Station (MVS) (Fig-1).
