## Field Safety Notice #423314 related to *exoplan 3.1 Rijeka*

**exocad product, commercial name:** *exoplan 3.1 Rijeka*

#### **Affected versions of *exoplan 3.1***

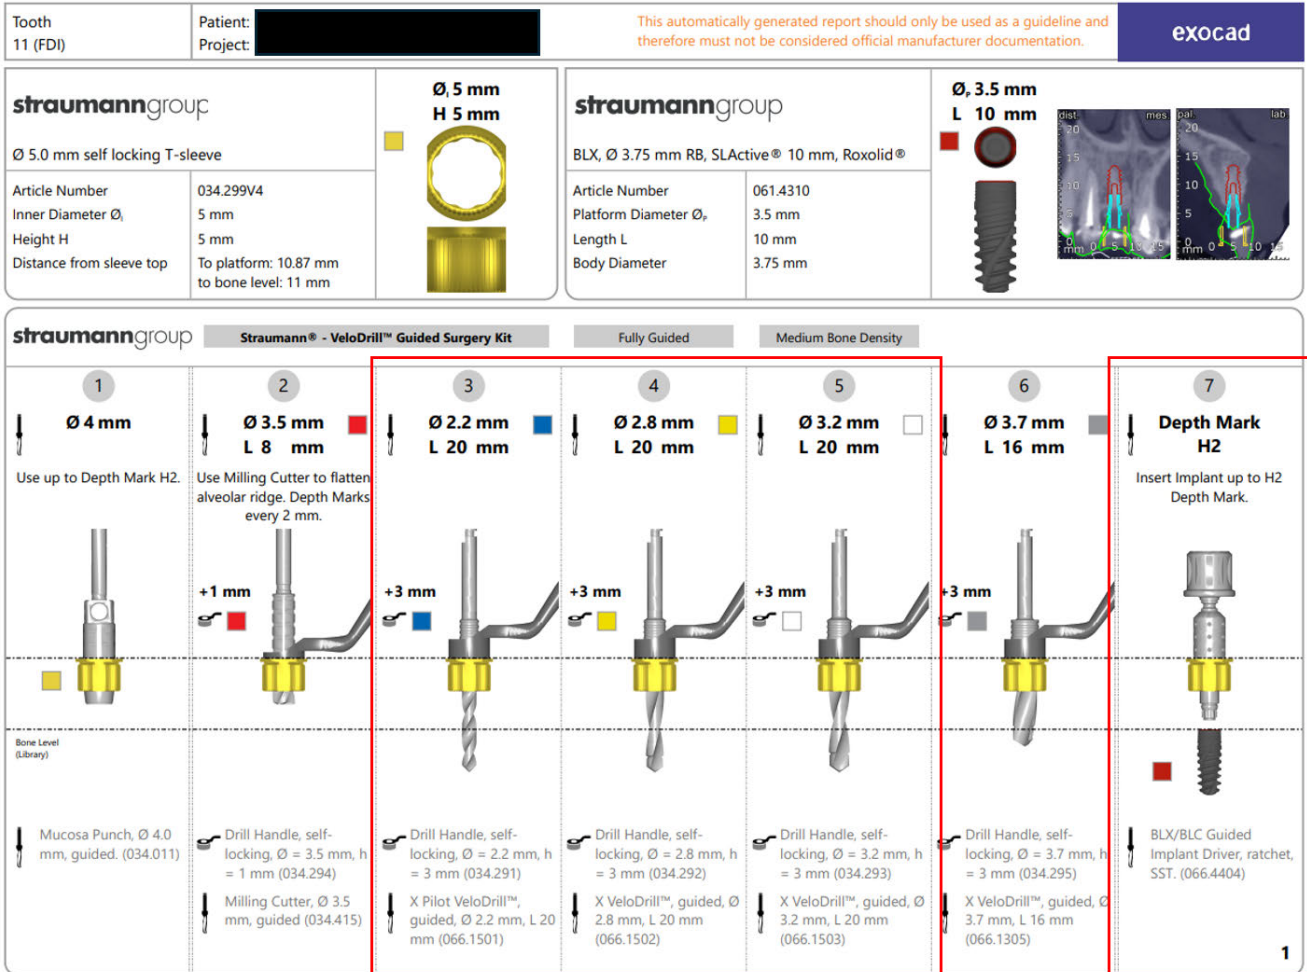
The displayed drill/tool sequence in the generated surgical report included drills with insufficient length for the planned implant position (see figure 1 below). The dentist did not notice this discrepancy prior to treatment. As a result, the prepared osteotomy was too shallow to place the implant as planned.

It is confirmed that it is a software issue and not a library issue that was already addressed in subsequent *exoplan 3.1 Rijeka* (EB 8752) or later.

**Figure 1:** Report from the end user who has reported the issue with the too shallow drilling. The red marked drill/tool sequence steps (no. 3-5,7) depicts the steps with the wrong (drill/tool length) information.

The dentist addressed the situation by using a longer drill in combination with a drill handle with a smaller offset in order to achieve the required implant depth while using the same surgical guide.

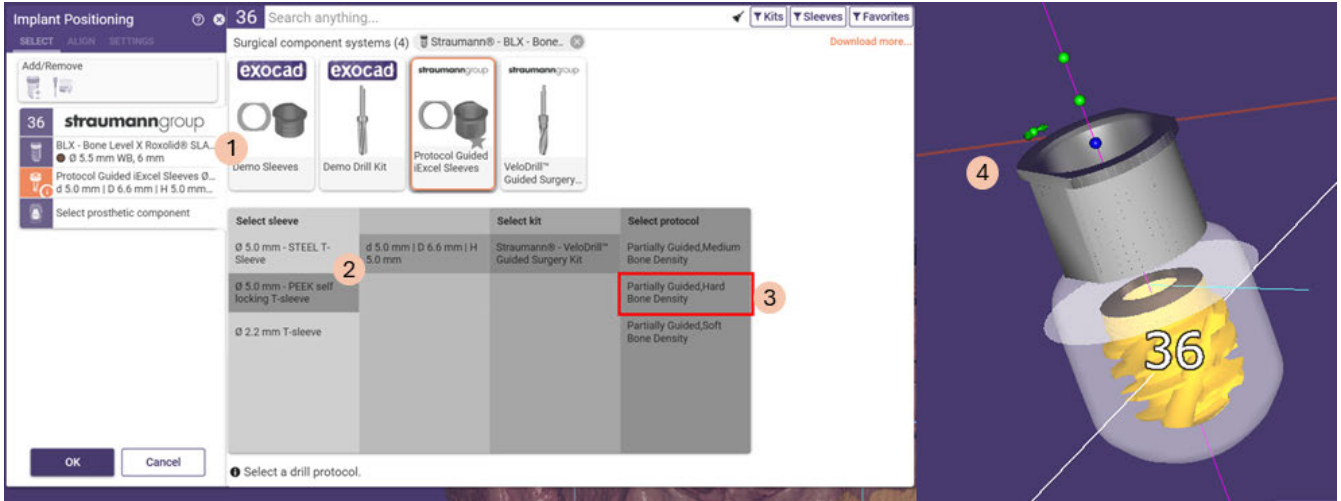
1. TLX/BLX implants with diameters of 5.5 mm and 6.5 mm and length of 6 mm (see “Affected implants” table below)
2. Ø 5.0 mm –T-sleeves (see “Affected surgical sleeves” table below)
3. Partially guided protocol, hard bone density
4. Sleeve offset 7 mm (closest of three available distances – marked as blue sphere in the figure 2 below)

**Figure 2:** Example of a library selection during implant planning that leads to a wrong library entry. (1) Choose one of the affected implants (see table below); (2) Select one sleeve with diameter 5.0 mm; (3) choose protocol “Partially Guided, Hard Bone Density”; (4) Choose closest distance between sleeve and implant.

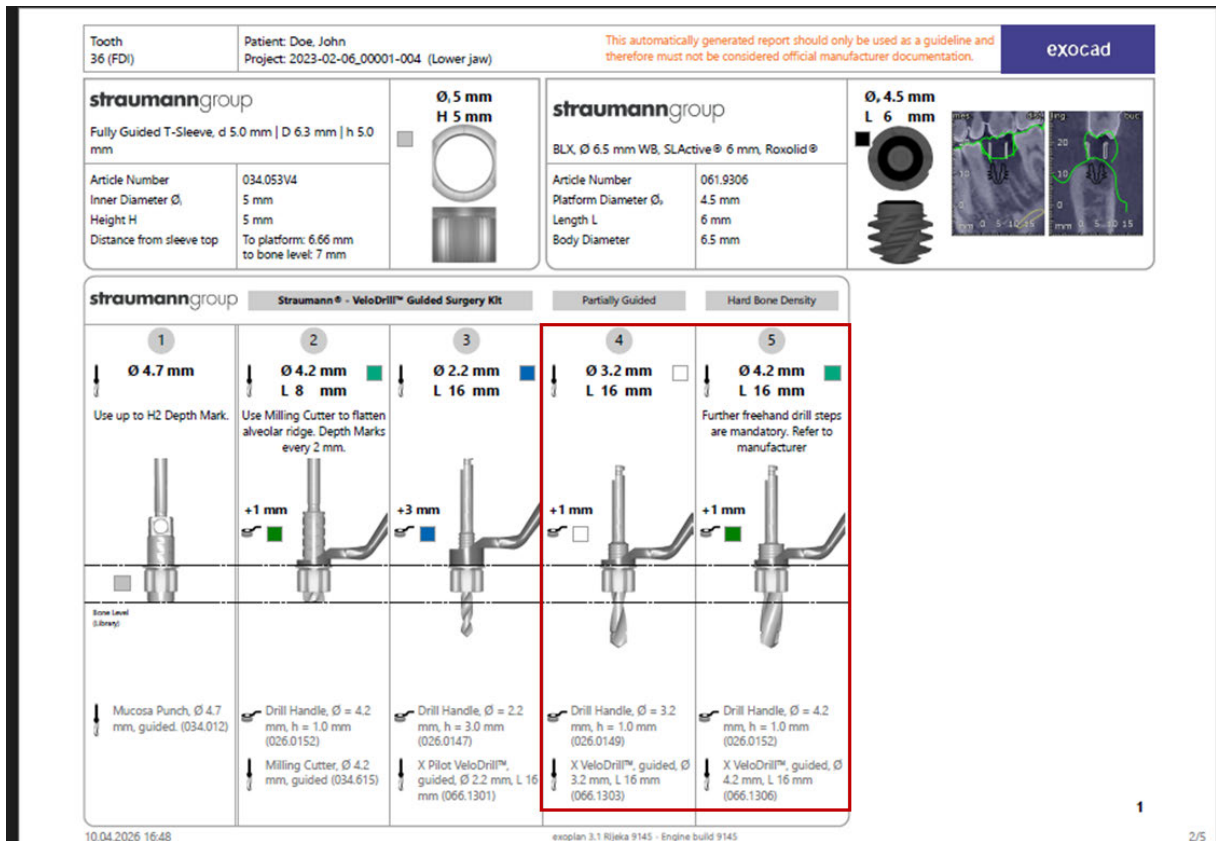
In this case, protocol steps 4 and 5 display the incorrect height of the drill handles for the used drills (marked red in figure 3 below):

Figure 3: Example step-by-step drill protocol output of *exoplan*. The drill step number 4 and 5 display the wrong drill handle (h1.0, marked red), step 3 displays the correct drill handle (h3.0).

If the incorrectly displayed protocol steps are followed, the user may select the wrong drill handle in steps four and five. This can cause the osteotomy depth to deviate 2 mm from the intended preparation depth.

1. The affected Straumann® libraries (see above) were removed from the download server and blacklisted on the exocad server on **April 16, 2026**. Consequently, these libraries are no longer visible or available for download by users.
2. New, corrected versions of the affected libraries have been made available for download at **Confidential business information**
3. As a result of the blacklisting, any attempt to select a component from an affected library will trigger a system message indicating that the selected protocol library is “unofficially extended/changed” and must no longer be used.  
This warning is displayed both at the time the blacklisted protocol library is selected and prior to the

- 1) Do not use the affected libraries – see section “Affected libraries” above – with *exoplan 3.1 Rijeka*.
- 2) If you are intending to use the affected Straumann® libraries, update all of them with the new, corrected versions available for download at **Confidential business information**
- 3) Upgrade to the latest *exoplan 3.1 Rijeka* version.

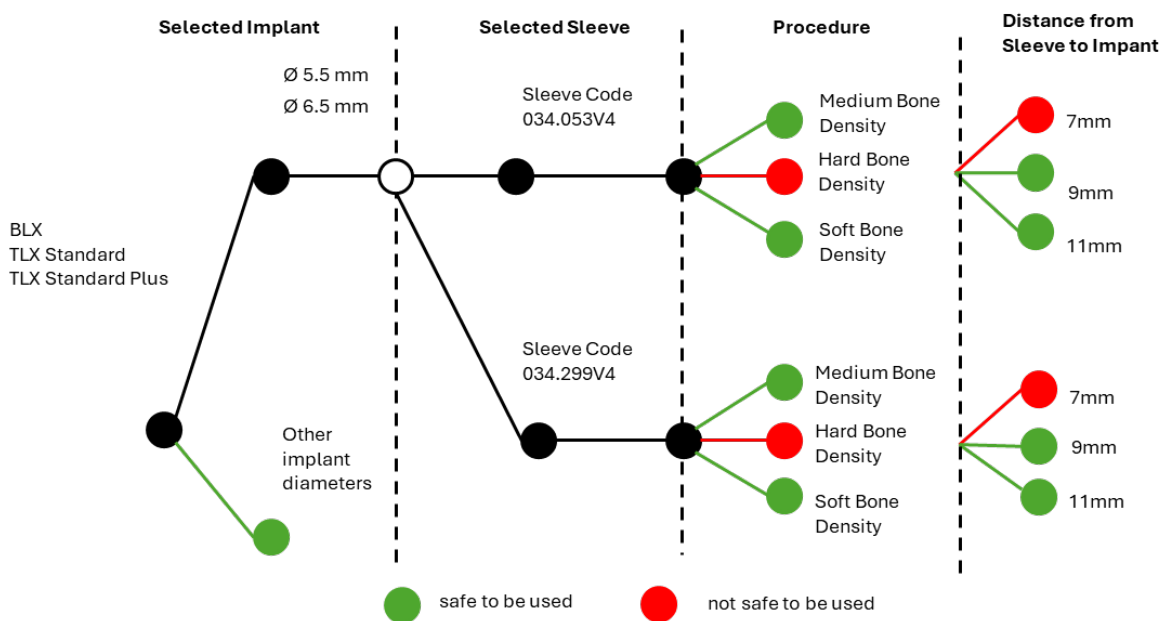
The usage of other Straumann® components is not affected. No other implant sizes, offset distances, surgical sleeves or protocol selections are affected. This chart showcases affected workflows. The red marked workflows are not to be used. Green workflow options are safe to use.

Figure 4: Combination of parameters available for affected Straumann® implant lines. The red circles indicate options that are not to be used. All green workflow options are safe to use.
