Updated Field Safety Notice

Philips MR Systems

Gradient Coil component failures may act as a heat source with potential to produce smoke and/or fire.

May 2026

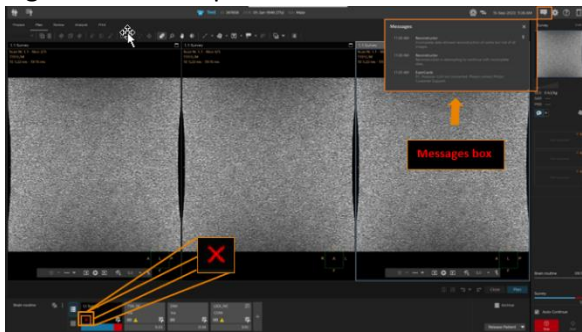
Figure 5. UI example SW Version R11.

- 4.3. When scan aborts occur the symbol is shown and applicable messages are presented in the message box (see Figure 5 and Figure 6 examples)
 - 4.3.1. Check the status of the error messages in the User Interface (UI) screen. Click to expand the message box in case previous messages are hidden, see orange box in Figure 5 and Figure 6 below. If possible, correct the issue that is relevant to the error shown and continue scanning, for example:
 - “RF door must be closed while performing scan. Scan aborted.”
 - “Patient support is moved while scanning, scan stopped.”
 - “Coil A (or B) failure, coil disconnected?”

- 4.3.2. If, after a scan abort, one of the following conditions occur five times in a row stop scanning immediately and contact Philips Service to describe the problem:
 - If there is no error message in the message box
 - If the error message meaning is not clear
- 4.3.3. If the error message “Gradient amplifier Rack Fault” is received two times in a row, or if the error message “Gradient amplifier Rack Fault” is preceded or followed by an aborted scan with no message, then stop scanning immediately and contact Philips Service to describe the problem.
- 4.3.4. If you encounter any of these conditions described in 4.3.2 or 4.3.3 do not attempt any additional/further scans, including without limitation do not attempt any

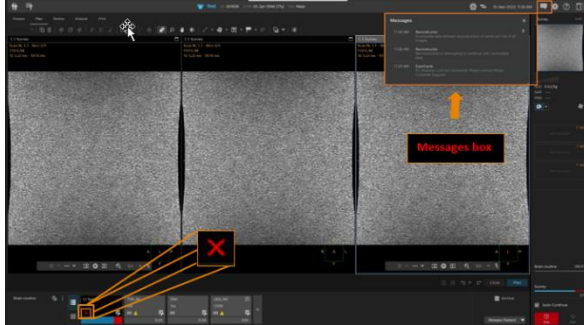
Figure 5. UI example SW Version R11.

- 4.3. When scan aborts occur the symbol is shown and applicable messages are presented in the message box (see Figure 5 and Figure 6 examples)
 - 4.3.1 Check the status of the error messages in the User Interface (UI) screen. Click to expand the message box in case previous messages are hidden, see orange box in Figure 5 and Figure 6 below. If possible, correct the issue that is relevant to the error shown and continue scanning, for example:
 - “RF door must be closed while performing scan. Scan aborted.”
 - “Patient support is moved while scanning, scan stopped.”
 - “Coil A (or B) failure, coil disconnected?”.

- 4.3.2 If, after a scan abort, one of the following conditions occur five times in a row stop scanning immediately and contact Philips Service to describe the problem:
 - If there is no error message in the message box
 - If the error message meaning is not clear
- 4.3.3 If the error message “Gradient amplifier Rack Fault” is received two times in a row, or if the error message “Gradient amplifier Rack Fault” is preceded or followed by an aborted scan with no message, then stop scanning immediately and contact Philips Service to describe the problem.
- 4.3.4 If you encounter any of these conditions described in 4.3.2 or 4.3.3 do not attempt any additional/further scans, including without limitation do not attempt any phantom scanning until your system has been checked and released by a Philips Service representative.
