Updated Field Safety Notice

Philips MR systems with MR Elastography (MRE)
Potential for inaccurate (lower) liver stiffness measurements

May 2026

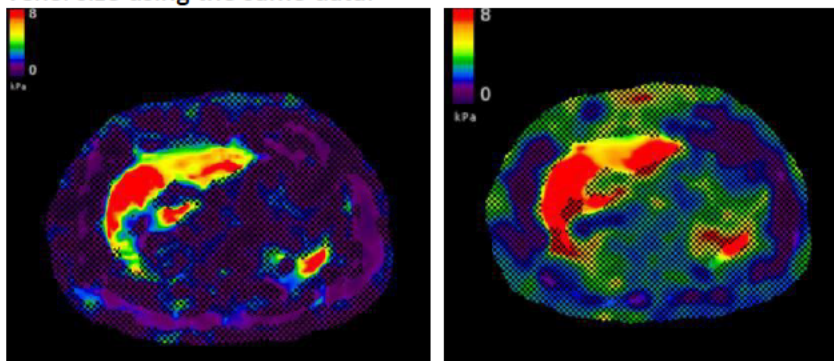
Philips has become aware through the MRE software system developer Resoundant about an issue affecting MRE stiffness measurements when a specific range of image reconstruction parameters is used in combination with Resoundant’s algorithm. Specifically, the reconstruction voxel size settings in the default MRE scan protocol are too small, which can potentially lead to inaccurate liver stiffness measurements (lower values). See Figure 1.

Figure 1. An example of what may occur. The left Elastogram was obtained with 1.17mm reconstruction voxel size from default MRE protocol and shows stiffness measurements in the liver are biased toward lower values. The right Elastogram was obtained with 1.65mm reconstruction voxel size using the same data.

If the liver stiffness measurement is underestimated, there is a potential for misdiagnosis of the fibrosis stage. This could then result in a delay of appropriate management and/or increased risk of patient harm due to unsuitable treatment.

3. On the Geometry tab make the following changes:
 - Change the FOV RL to 480 mm
 - Change the Recon voxel size RL to 1.5mm
 - Accept the changes

A Philips representative will contact you to schedule time for a Field Service Engineer (FSE) to install a software upgrade to resolve the issue (reference 2026-PD-MR-003). The software upgrade is expected to be available by March 2027 (dependent on regulatory approval per country).
