## **URGENT Field Safety Notice**

### **Philips Azurion and Allura Systems**

Potential loss of imaging functionality (Allura/Azurion), loss of motorized movement (Allura), or loss of data (Allura) due to unauthorized Hard Disk Drives

17-JUN-2026

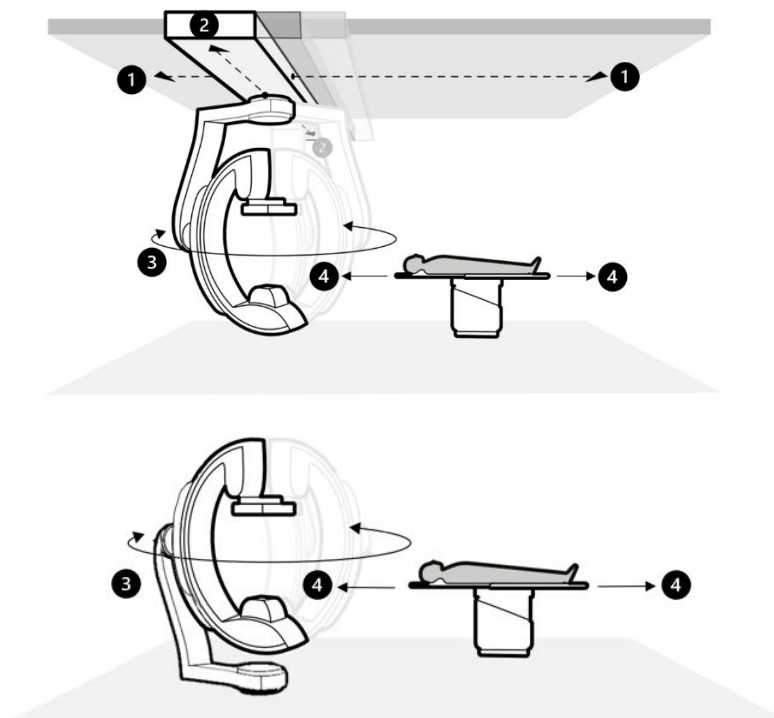
Figure 1 – Manual movements of the ceiling-mounted system (top) and floor-mounted system (bottom)

- Circulate this Urgent Field Safety Notice to all users of the system so that they are aware of the issue and follow the instructions below.
- In case motorized movements are unavailable, the stand can be manually repositioned using the handgrips and brake controls located on both sides of the stand. For ceiling-mounted systems, manual longitudinal (1), transversal (2) and rotational (3) stand movements remain available. Note: Transversal stand movements (2) are only available for ceiling-mounted systems with the FlexMove option. For floor-mounted systems, only rotational (3) stand movements remain available. The table longitudinal position (4) can be adjusted manually, when the table is not tilted (see Figure 1 below).
